## APPENDIX C

EHTESHAMI PROPERTY  
21 Estrada Place,  
Redwood cCty, San Mateo County, California.

**REPORT**  
**GEOTECHNICAL INVESTIGATION**  
**INCLUDING SLOPE STABILITY ANALYSIS**  
**AND GEOLOGIC HAZARD ASSESSMENT**

**PROPOSED RESIDENCE ON PARCEL 1  
21 ESTRADA PLACE, REDWOOD CITY  
SAN MATEO COUNTY, CALIFORNIA**

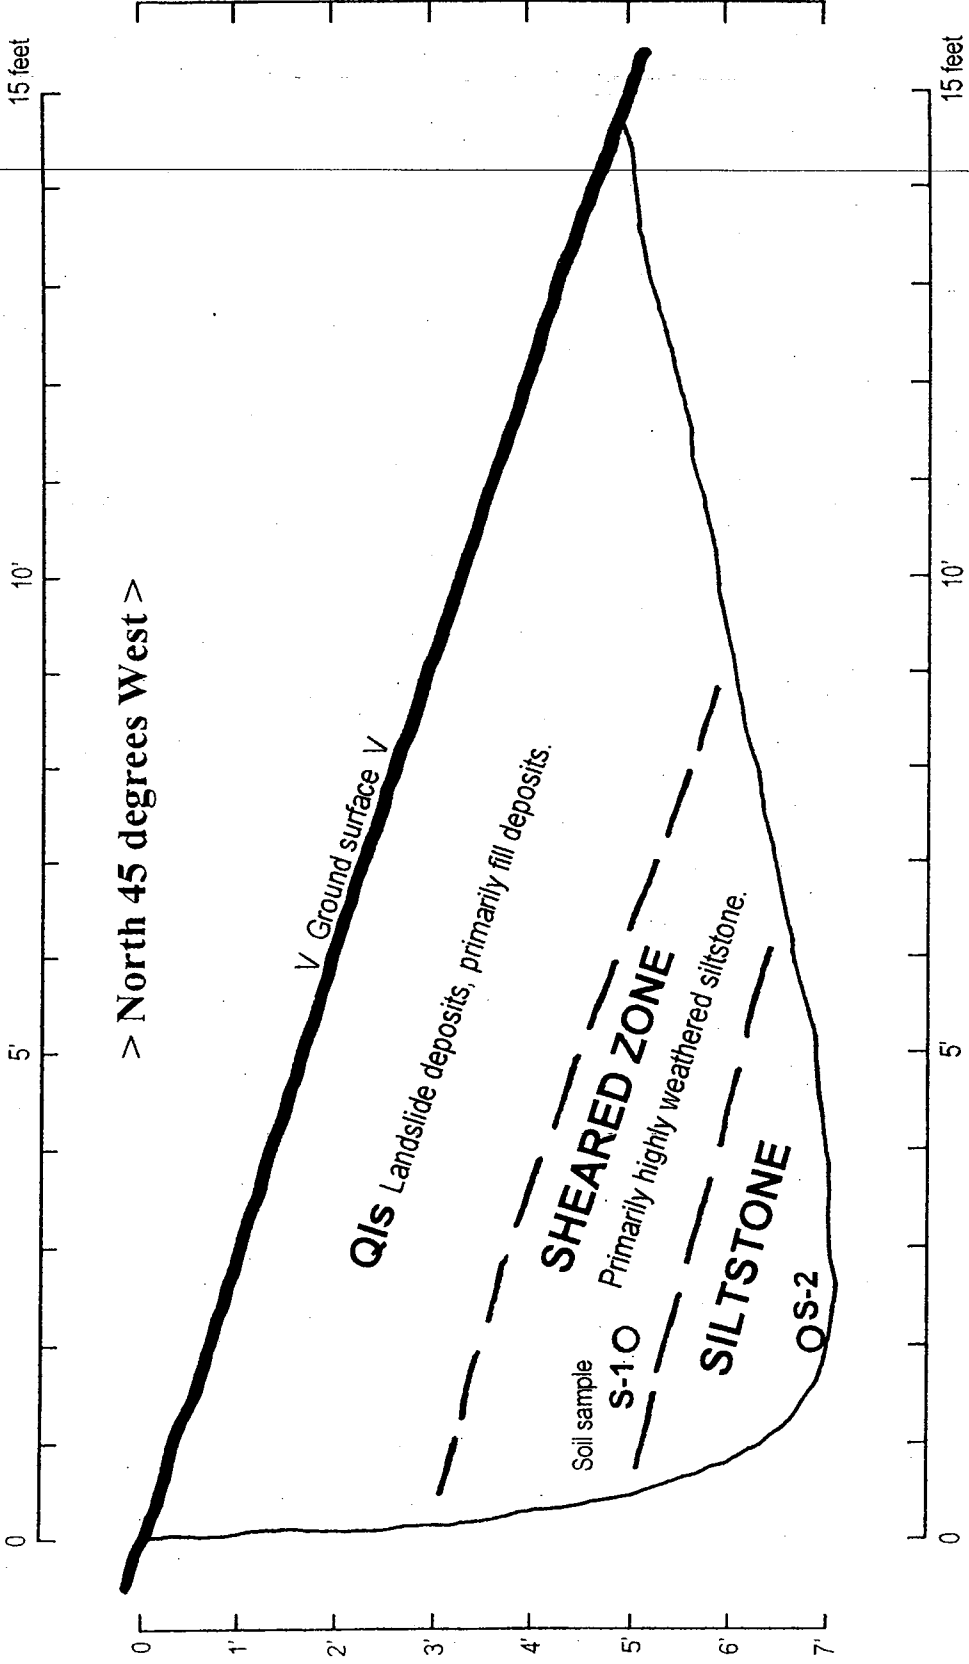
Test pit 14 was excavated at the base of the existing head scarp on the site (see **Figure 2** and photographs on **Figure 9**). The pit extended to a depth of approximately 7 feet. The upper 3 feet consist of disturbed material, which are referred to as land slide deposits. They consist primarily of fill deposits including angular blocks of various Franciscan Assemblage rocks in a matrix sandy to silty clay that have failed since the grading was carried for Parcel 2. The slide deposits overly approximately 2 feet of clay and silt that appear to be highly weathered siltstone. The weathered material is characterized by numerous shears that dip sub-parallel to the ground surface and is identified as a sheared zone on **Figure 6**. The base of this unit appears to be the

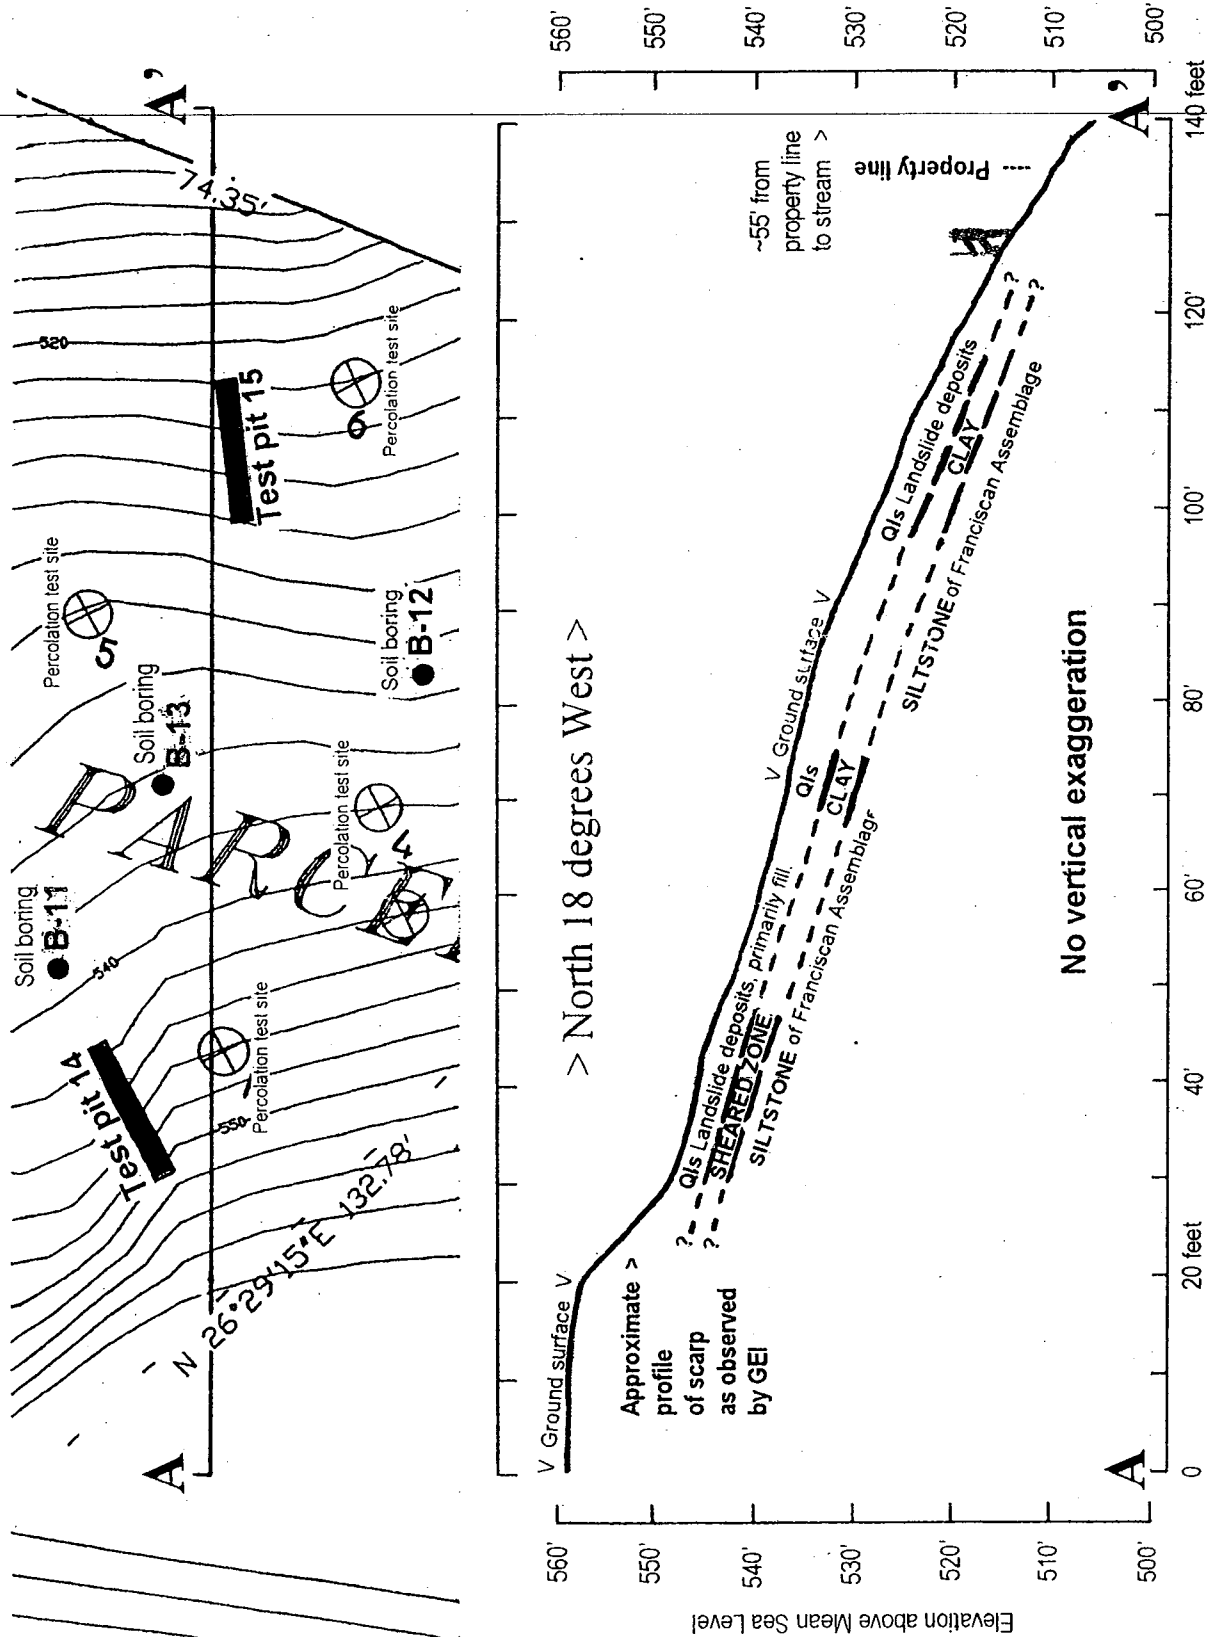
Figure 8  
**CROSS-SECTION A - A'**

Various methods of analysis have been used for investigating the stability of slopes. A surface of rupture is assumed for the mass, which tends to slip. Based upon the borings and test its, the probable failure surfaces has been located as shown on figure 8, cross section A-A'.

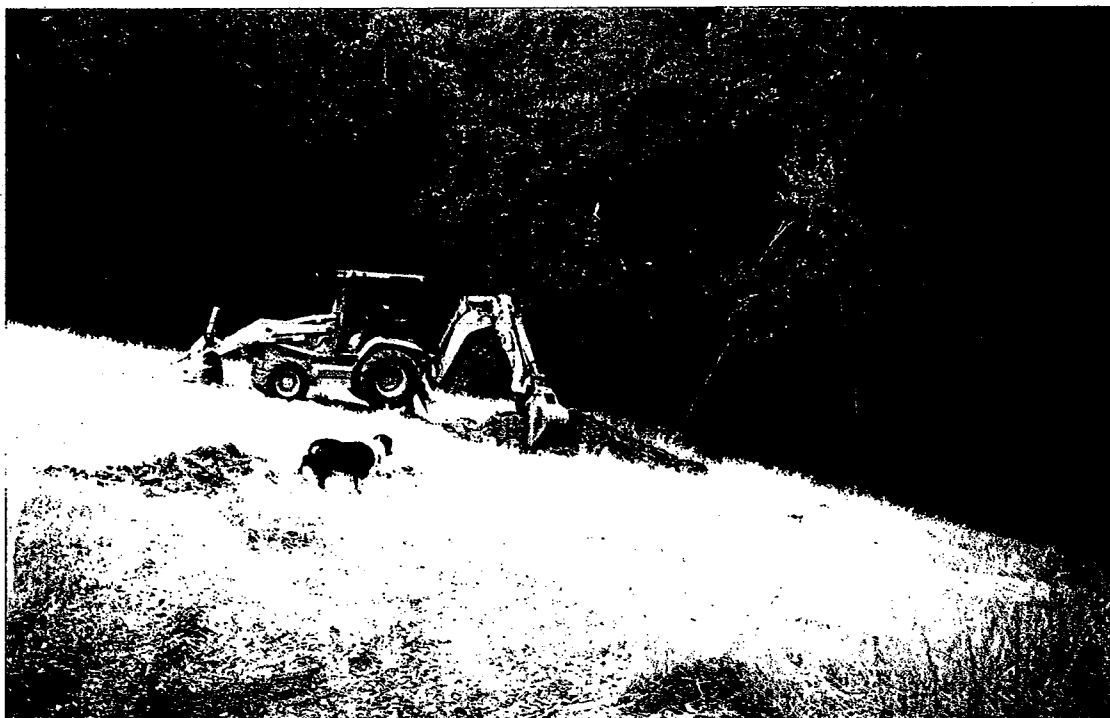
**View of northwestern portion of site. Excavating Test Pit 15.**
