Environmental Assessment Moisture Assessment Report

**1 Circle Star Way / 1st Floor
San Carlos, CA 94070**

Moisture Assessment Report

Phoenix Environmental Consulting was contracted to perform third party verification of current moisture levels in previously damaged construction materials prior to replacement of new. The commercial office building is a 4 story structure comprising approximately 103,000sqft of space. Our inspection, for this report, was limited to the 1st floor areas as presented to PEC by Restoration Management and Novo Construction. Drying services were performed by contractor: **RESTORATION MANAGEMENT COMPANY prior to our inspection.** Areas in the kitchen, and corridor are scheduled for removal due to visible mold growth. Environmental services included a visual and tactile examination of materials using industry standard moisture meters and documenting photographs. The source of the water loss was the third floor restroom.

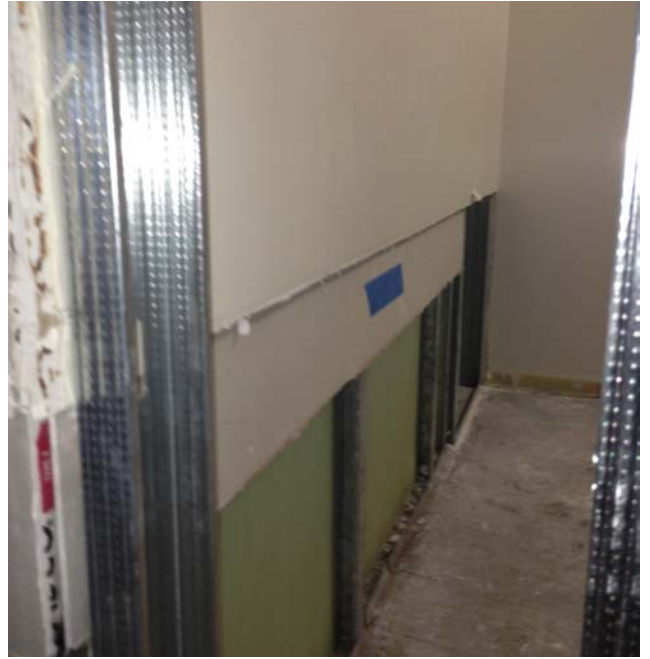
Triple layered construction
