Orchard Commercial  
**Project 7700**  
2013 Annual Roof Survey

Re: 2013 Annual Roof Survey Report for **Project 7700**

# Roof Inspection Report **Project 7700**

**Project 7700** consist of two four story buildings located in San Carlos, CA 94070 at:

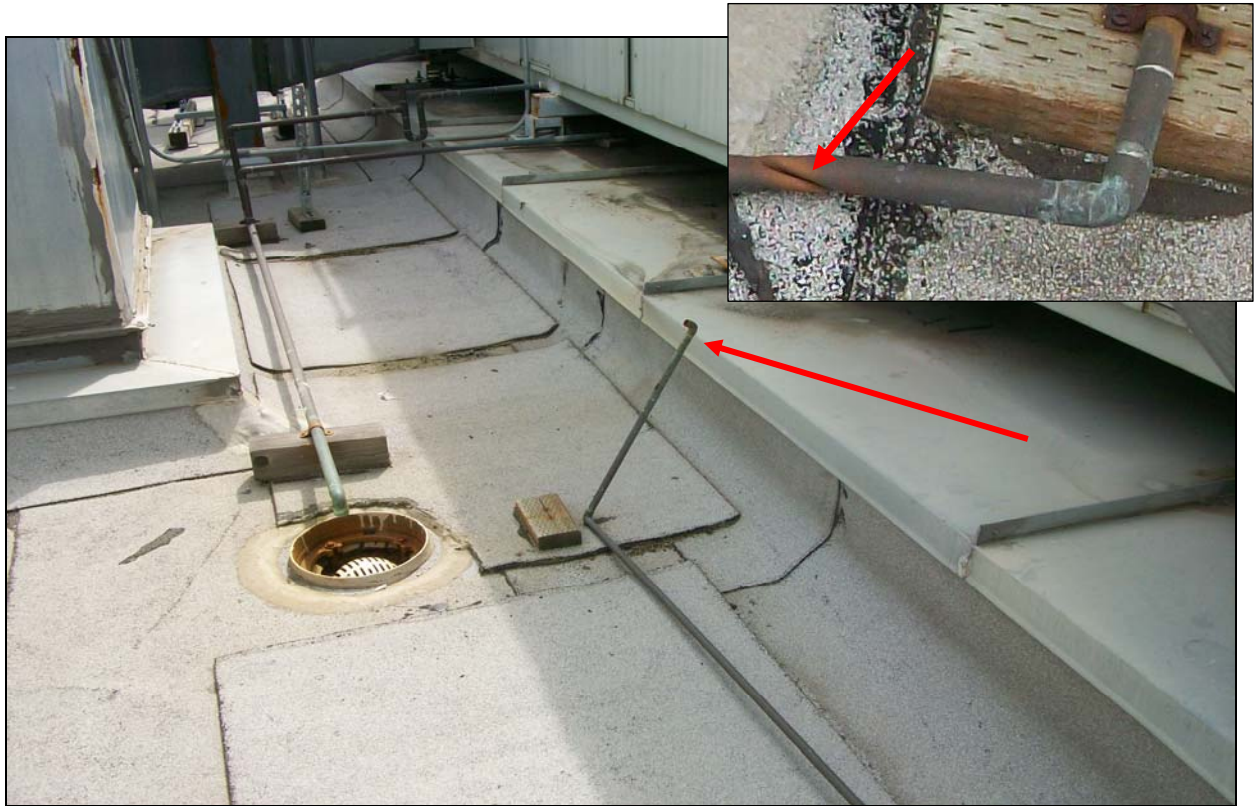
- Electrical distribution/junction boxes are insufficiently supported
- HVAC condensation line is bent to obstruction (needs replacement)

Bent / Obstructed Condensation Line

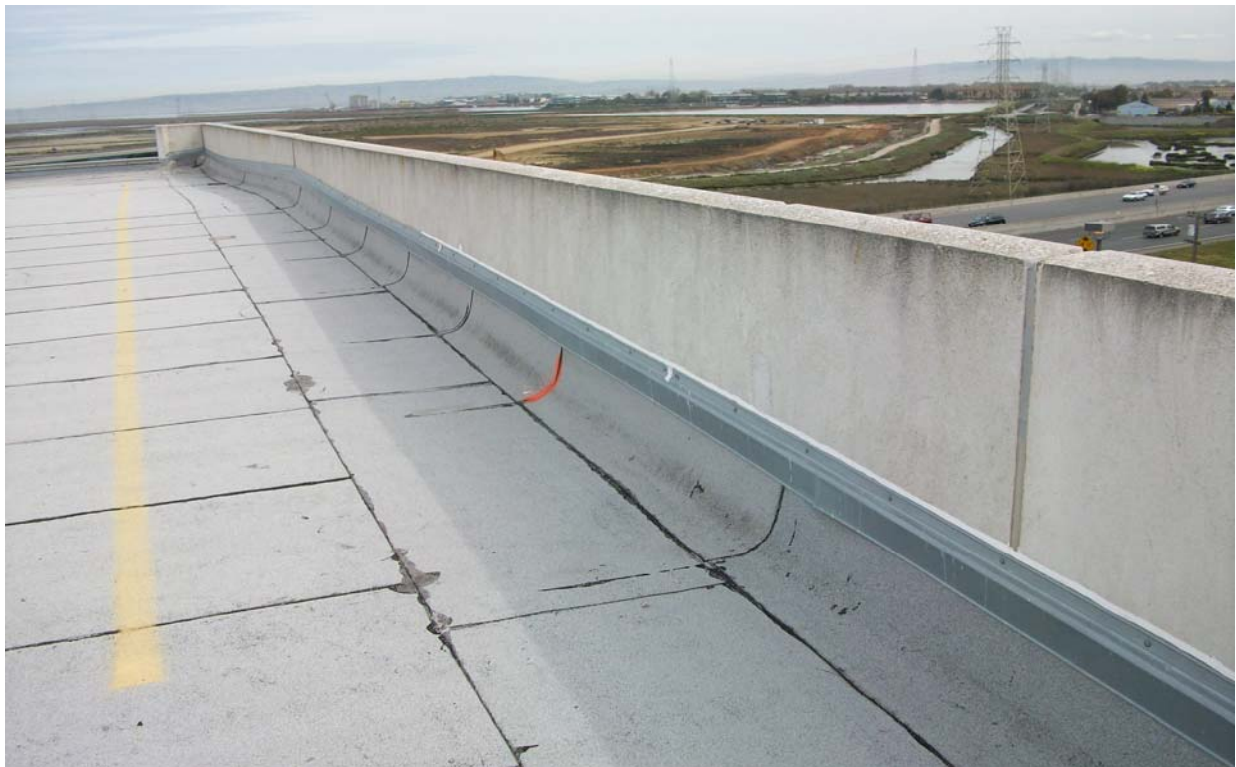
Open Base Flashing Seams

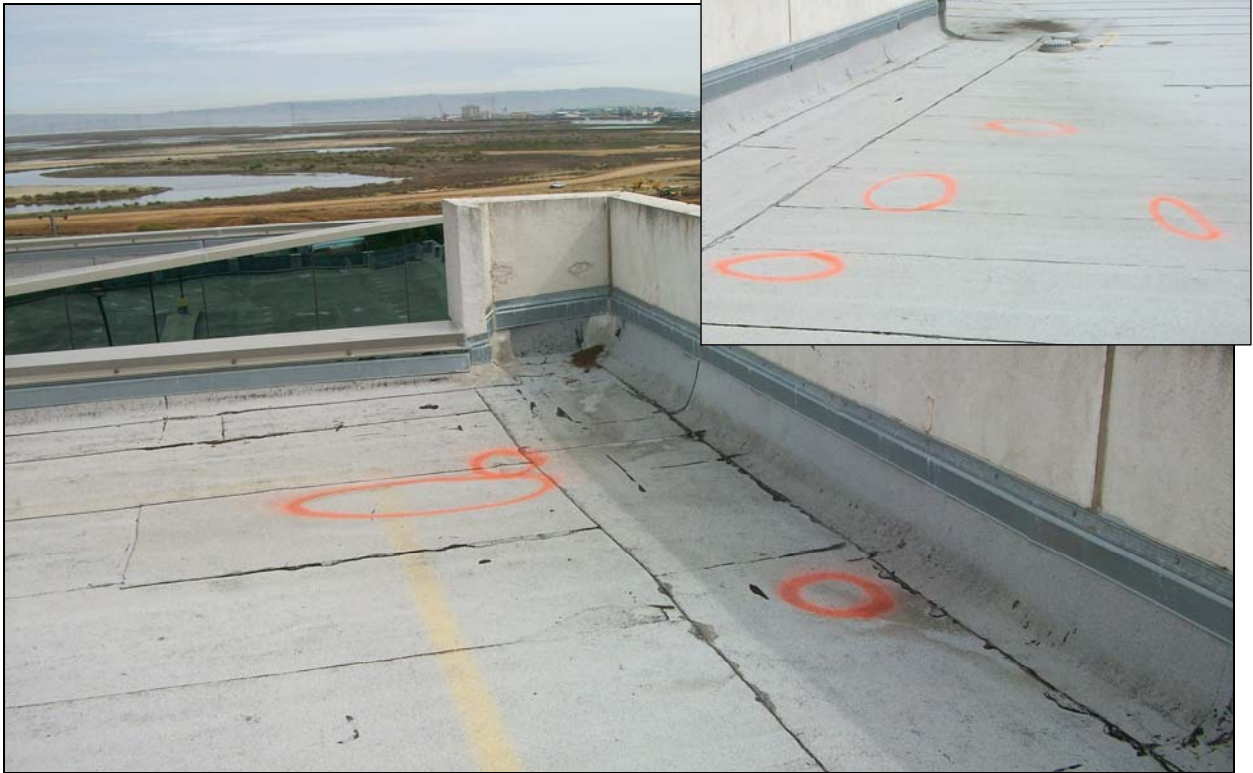
Field Blisters

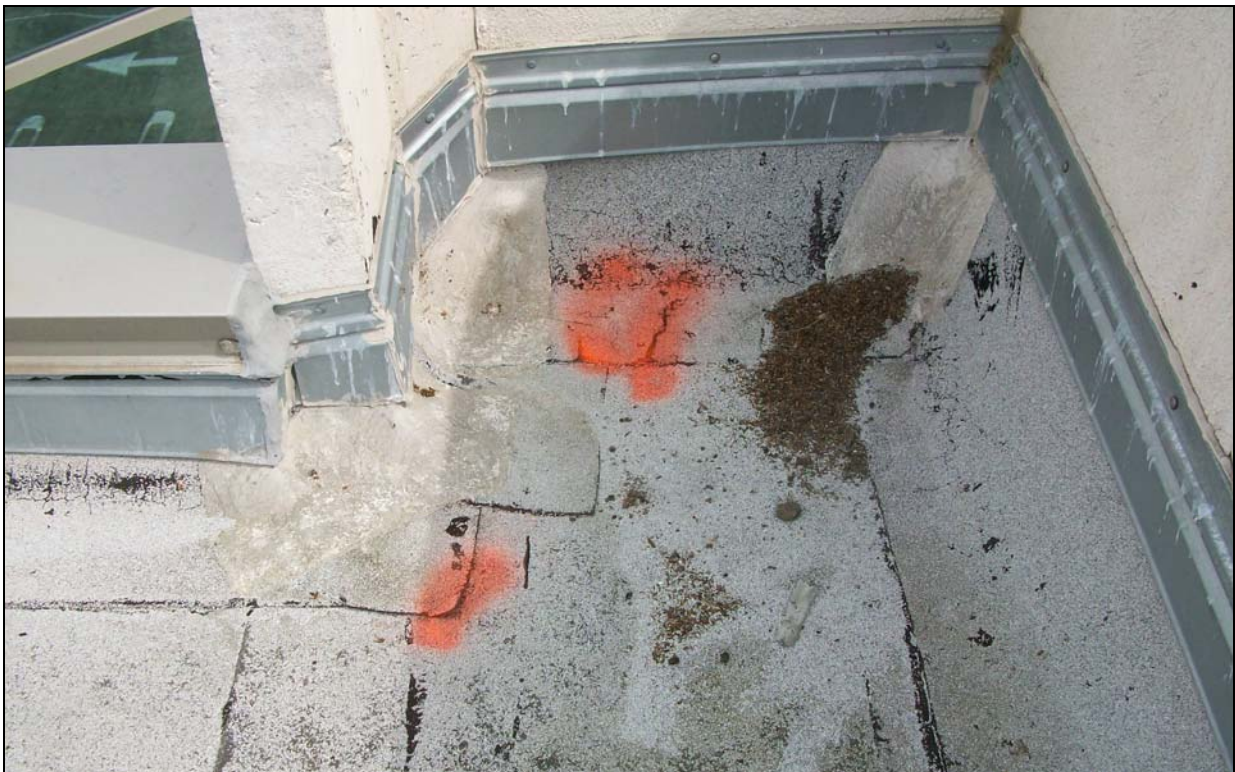
Base Flashing Repairs

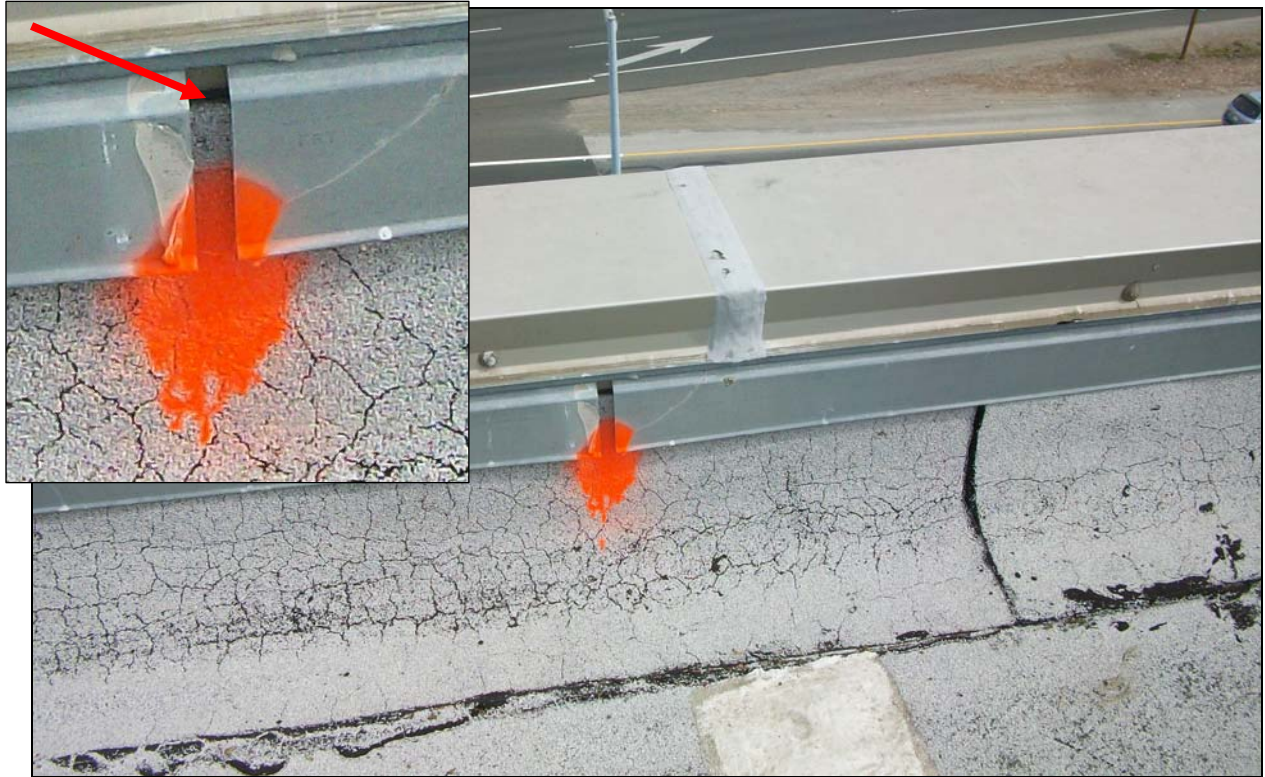
Open Reglet Seam – Expose Base Flashing

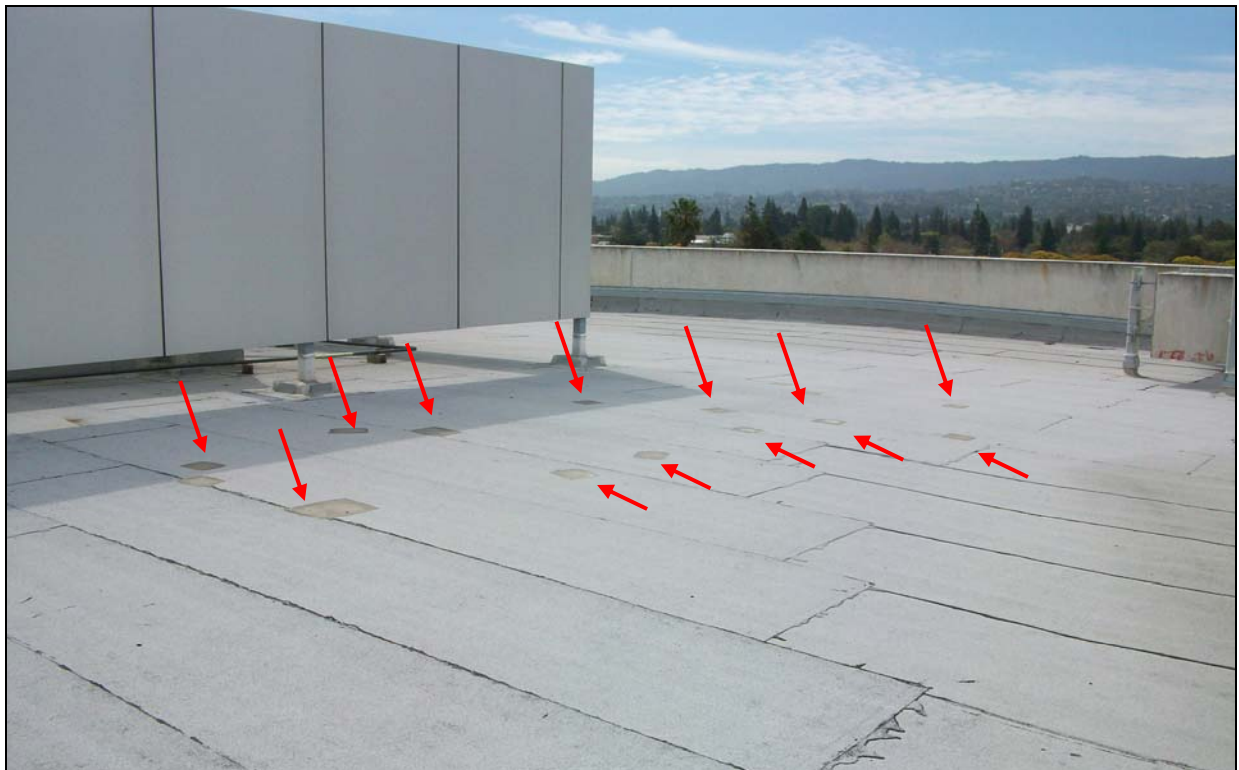
Previous Repairs (Small)

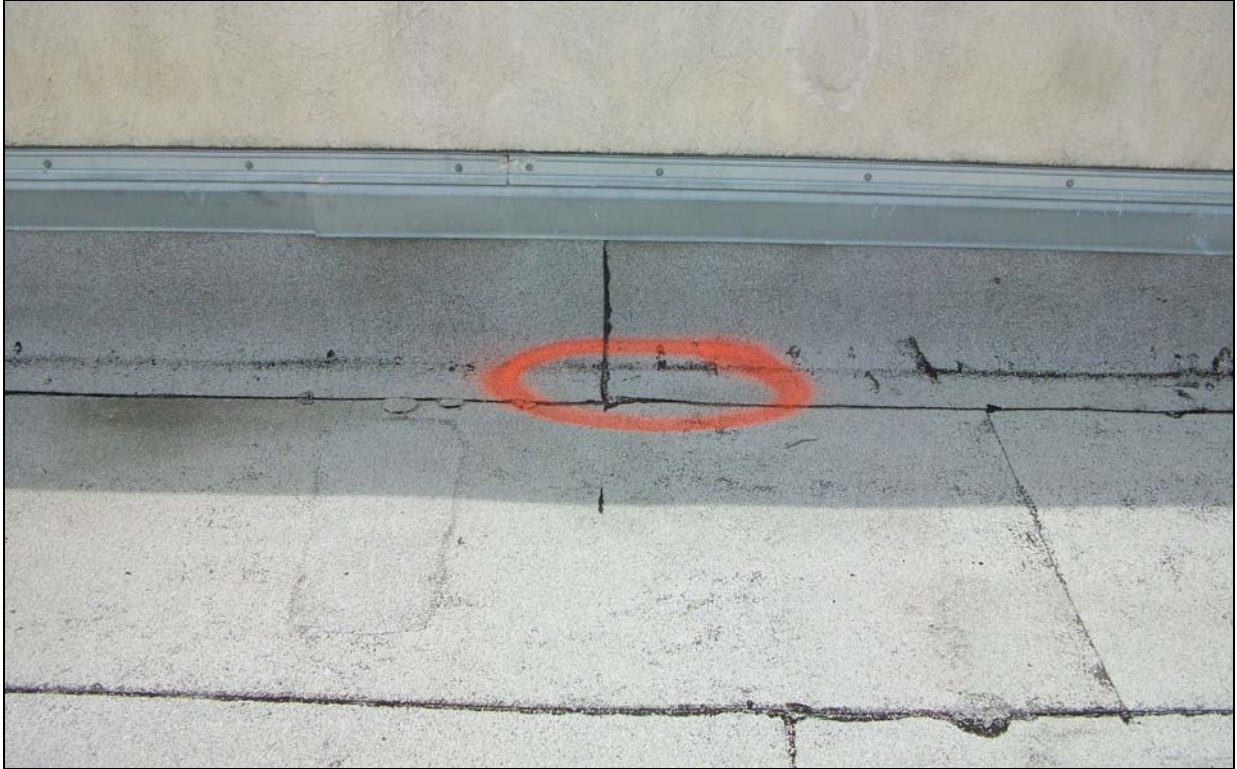
Base Flashing Blisters

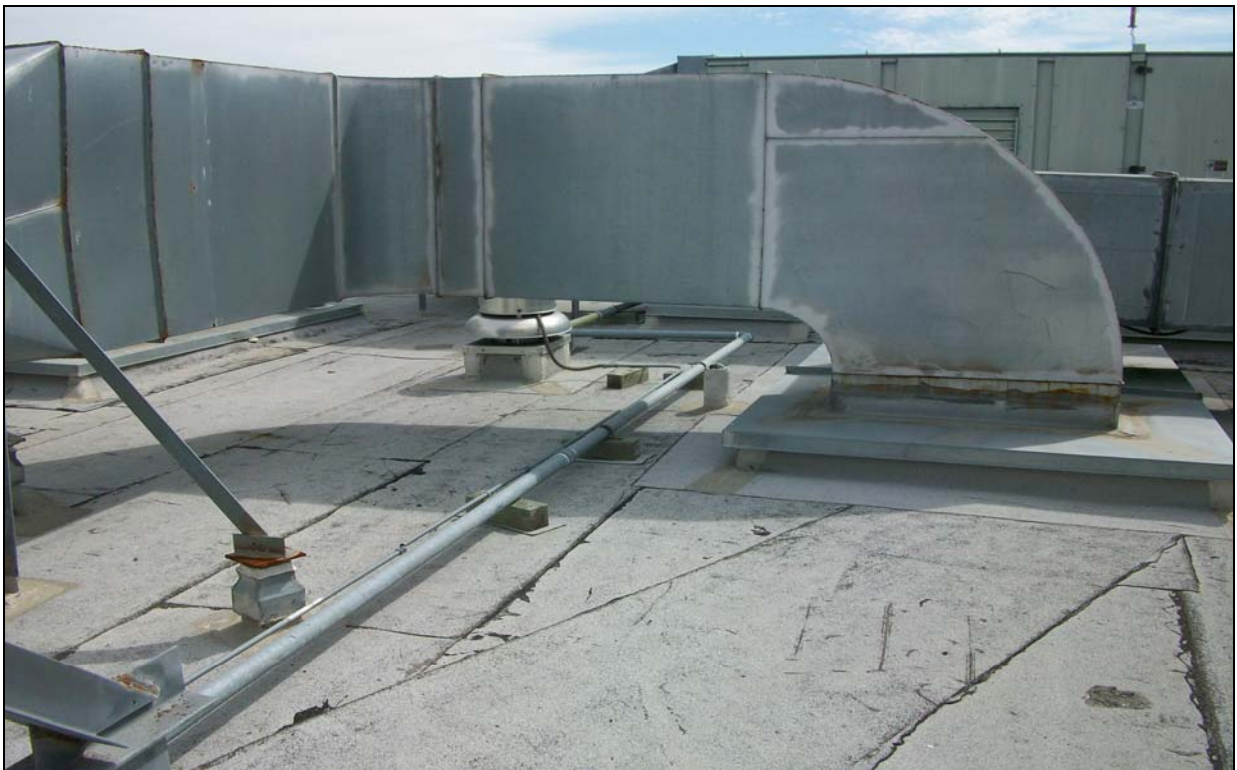
Cap-Sheet Scoring (Mechanical Service Personnel)

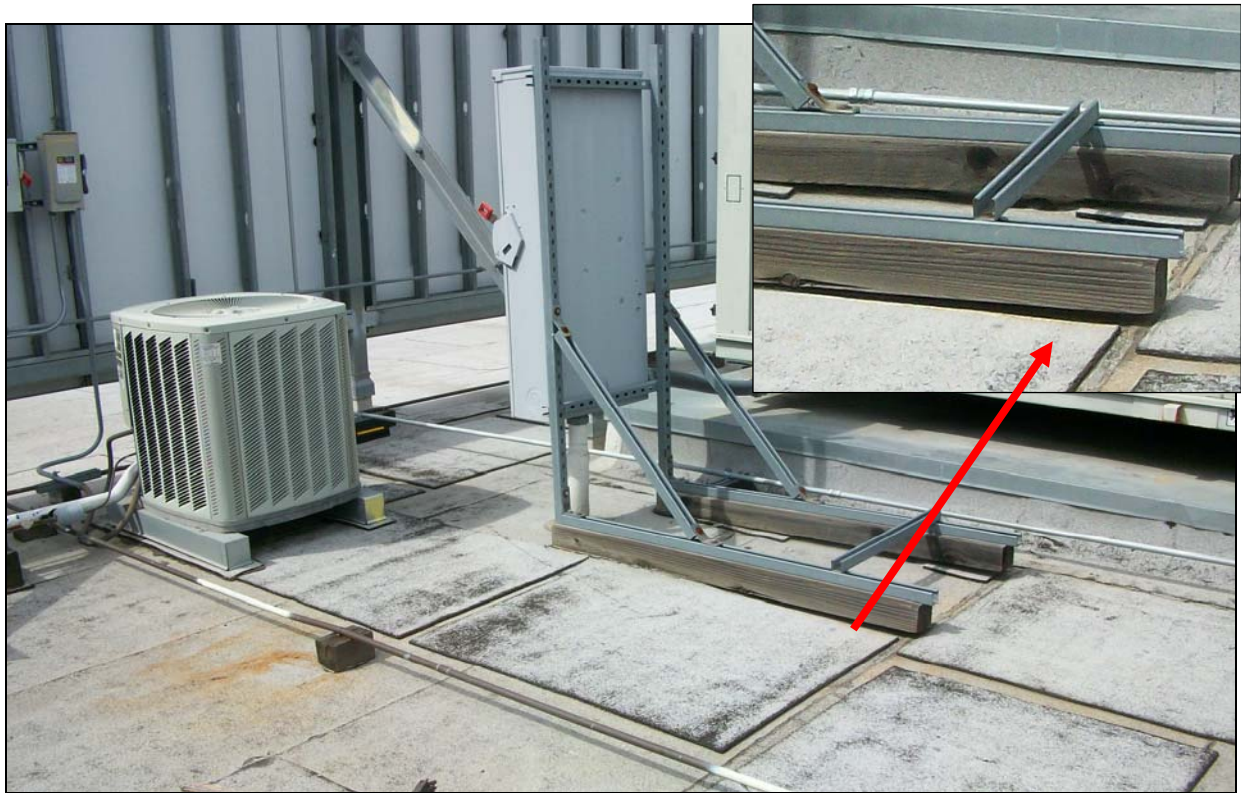
Electrical Box Movement – Unsupported Weight

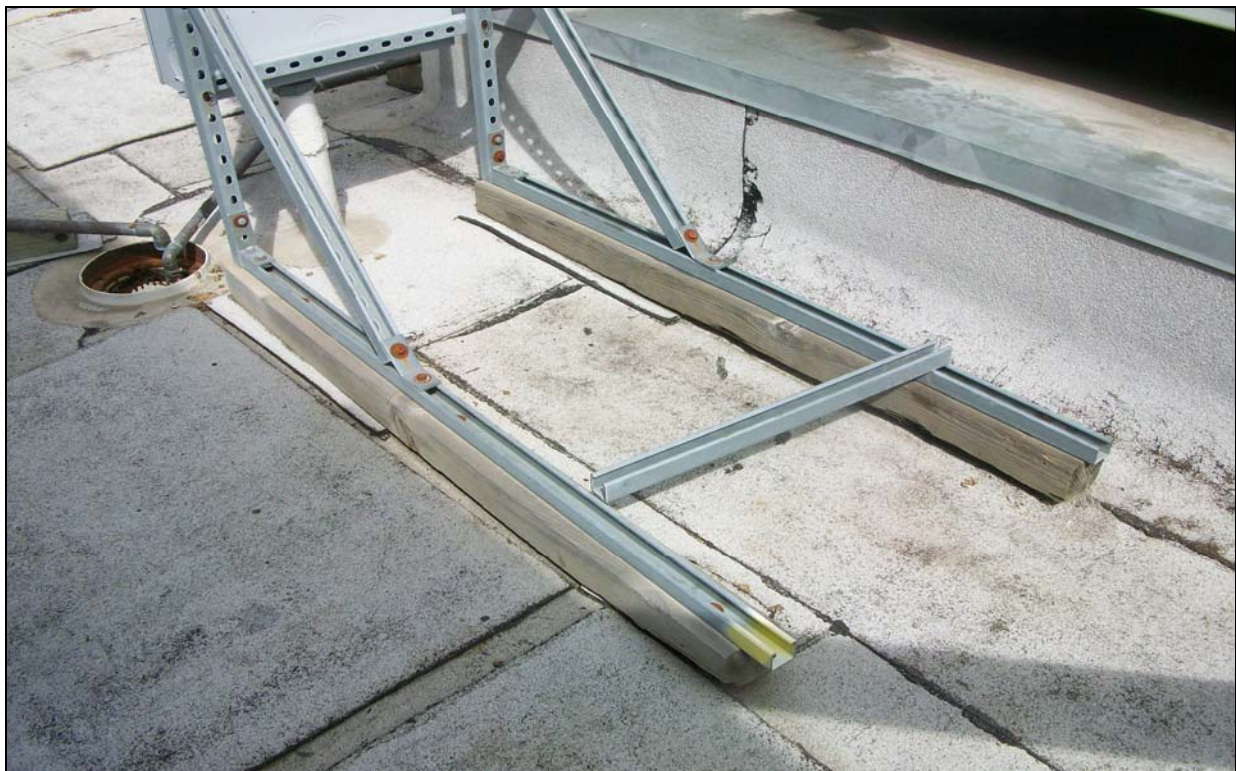
Electrical Box Installations – Unequal Weight Distribution (typical)

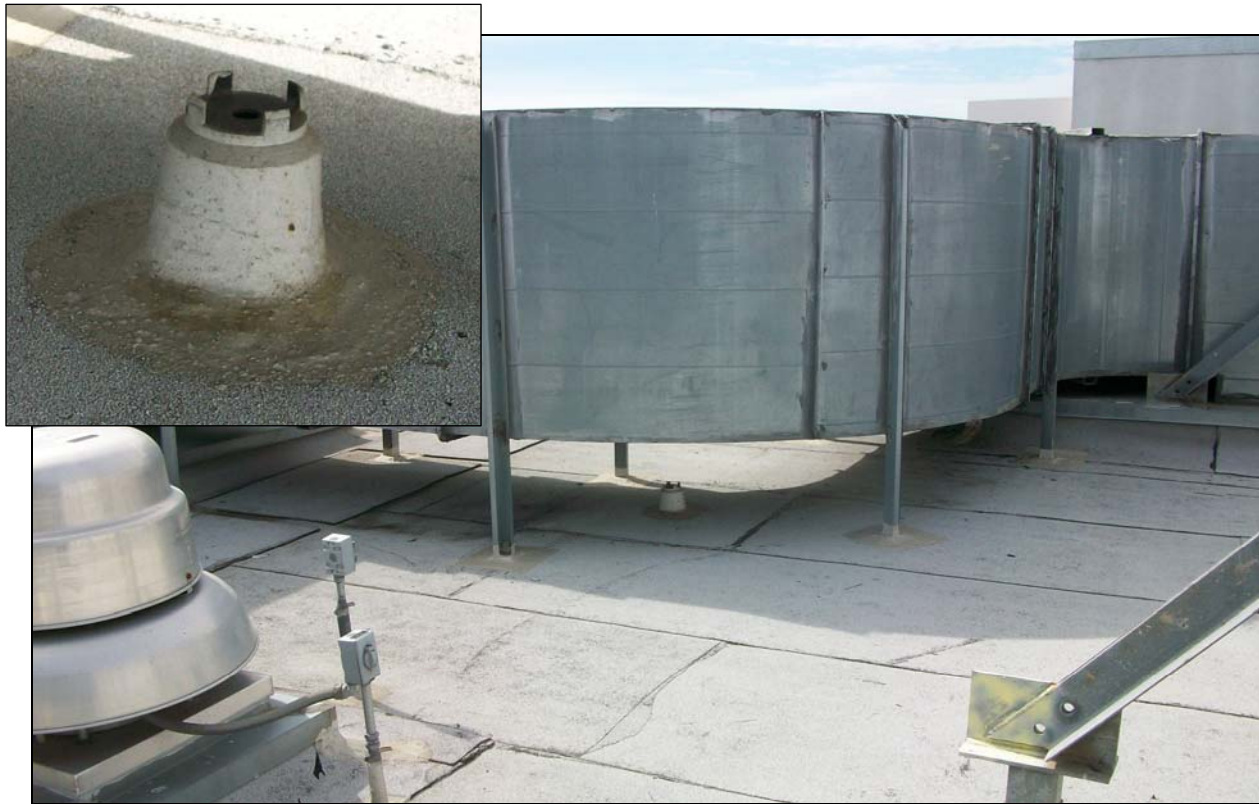
- Protection pads at Ventilation Duct Supports have been sealed with acrylic
- One breather vent (under Ventilation Duct) missing cover

Breather Vent Missing Cap

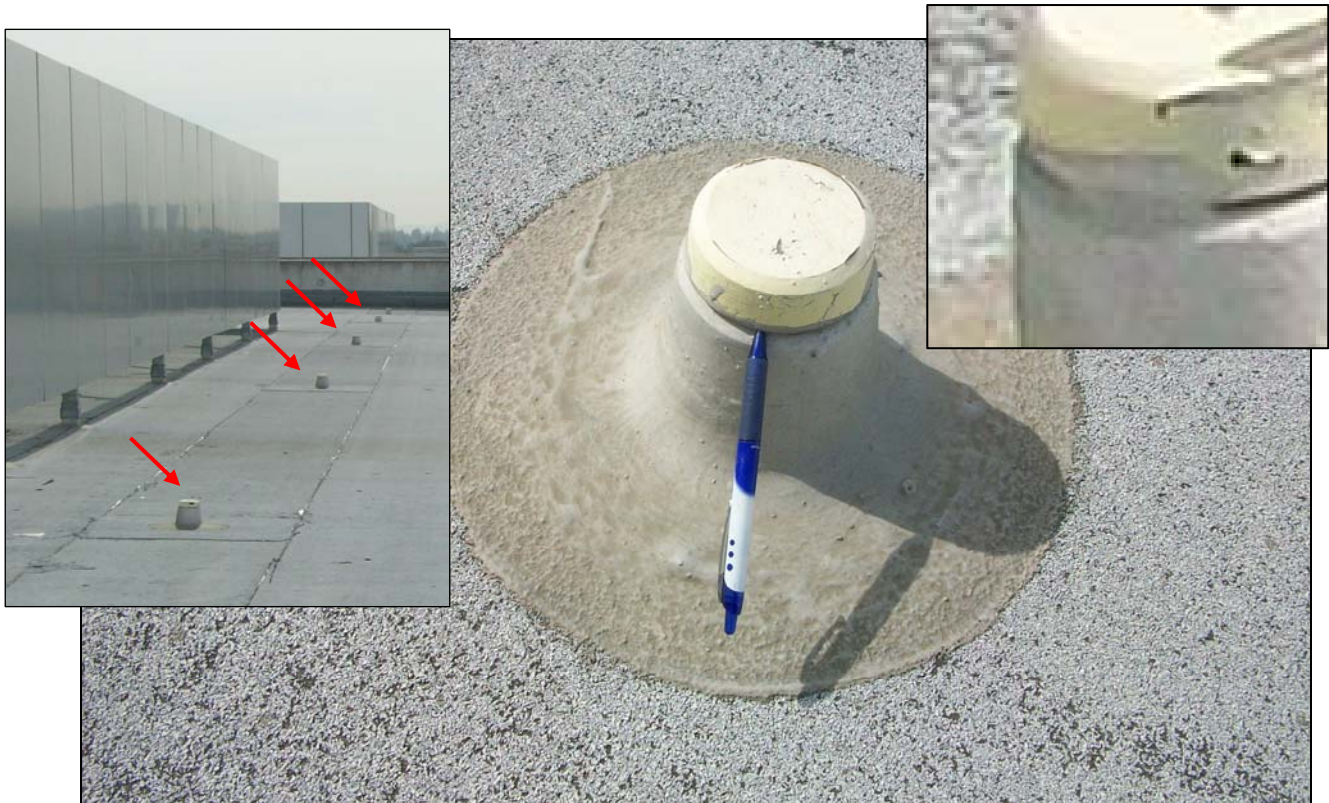
- Breather vents have been sealed by previous roof repairs

Roof System Breather Vents - Decommissioned by Previous Roof Repairs

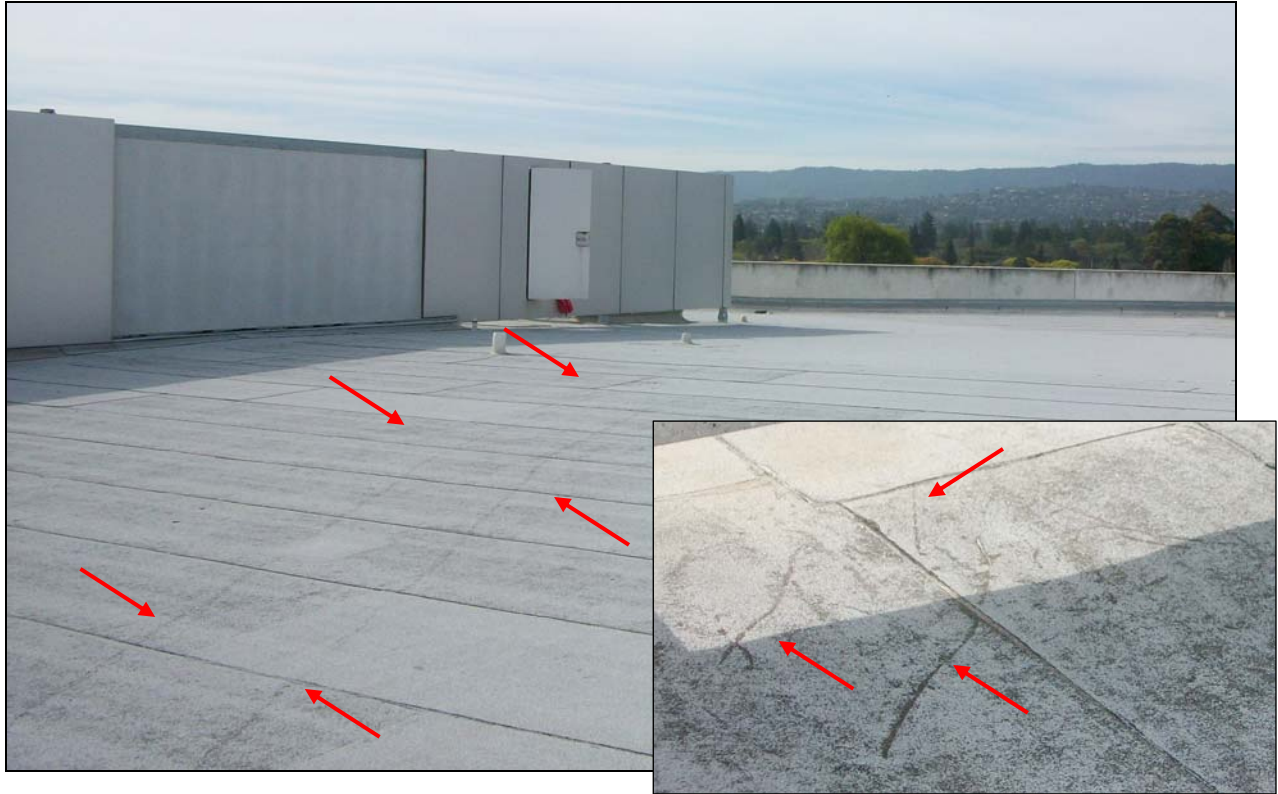
Membrane Scoring (poor care by service personnel)

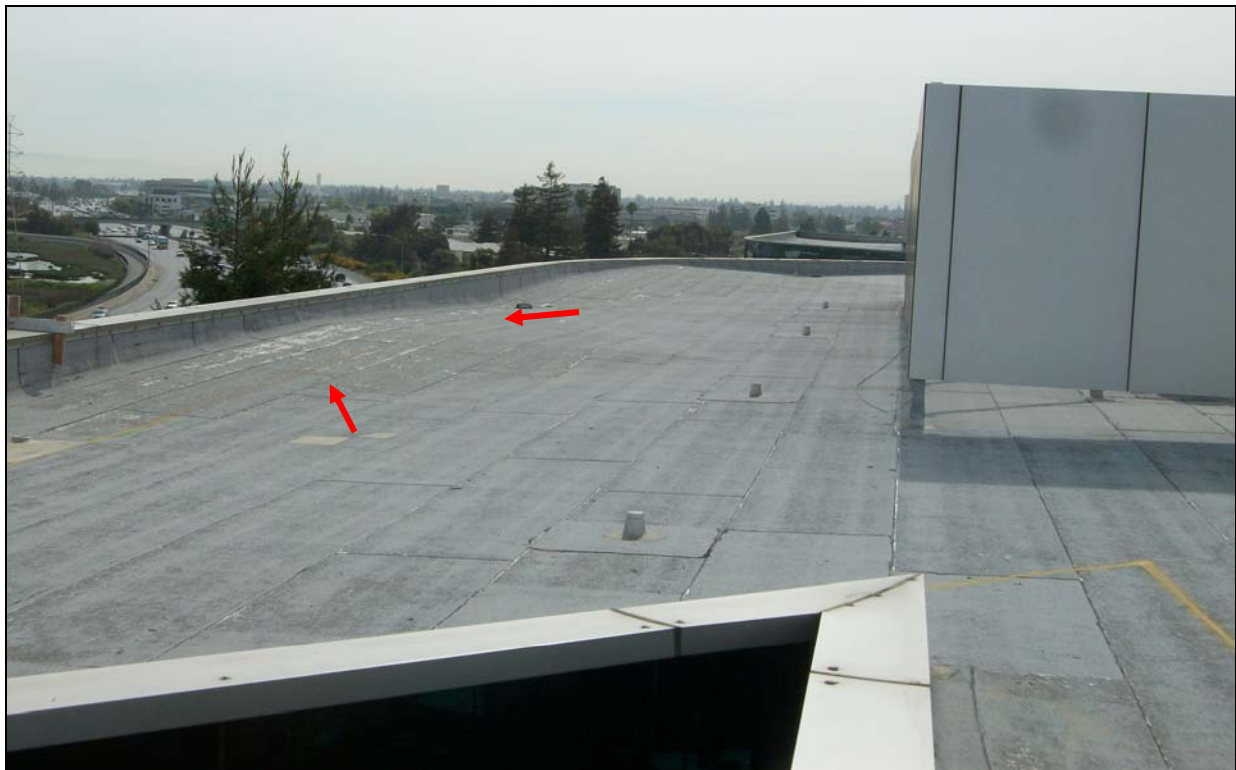
Extensive Granule Loss

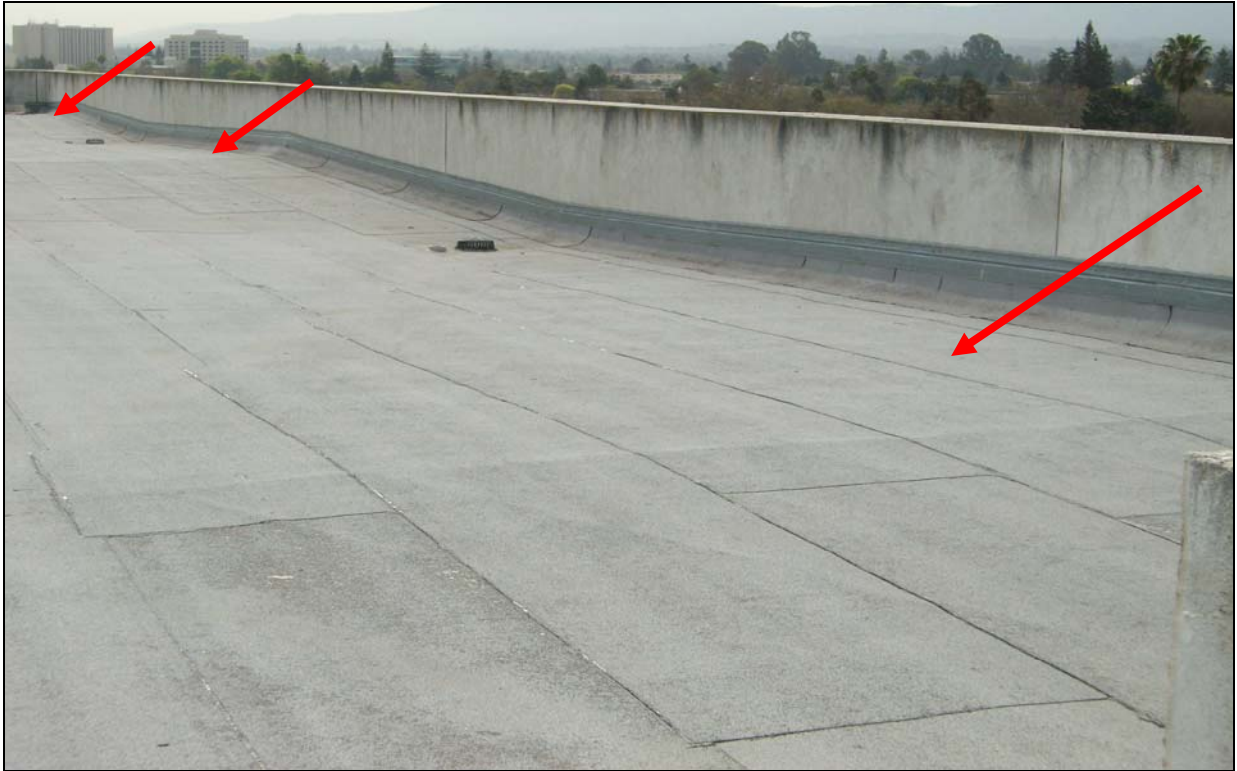
Membrane Ridging Deflection Crickets

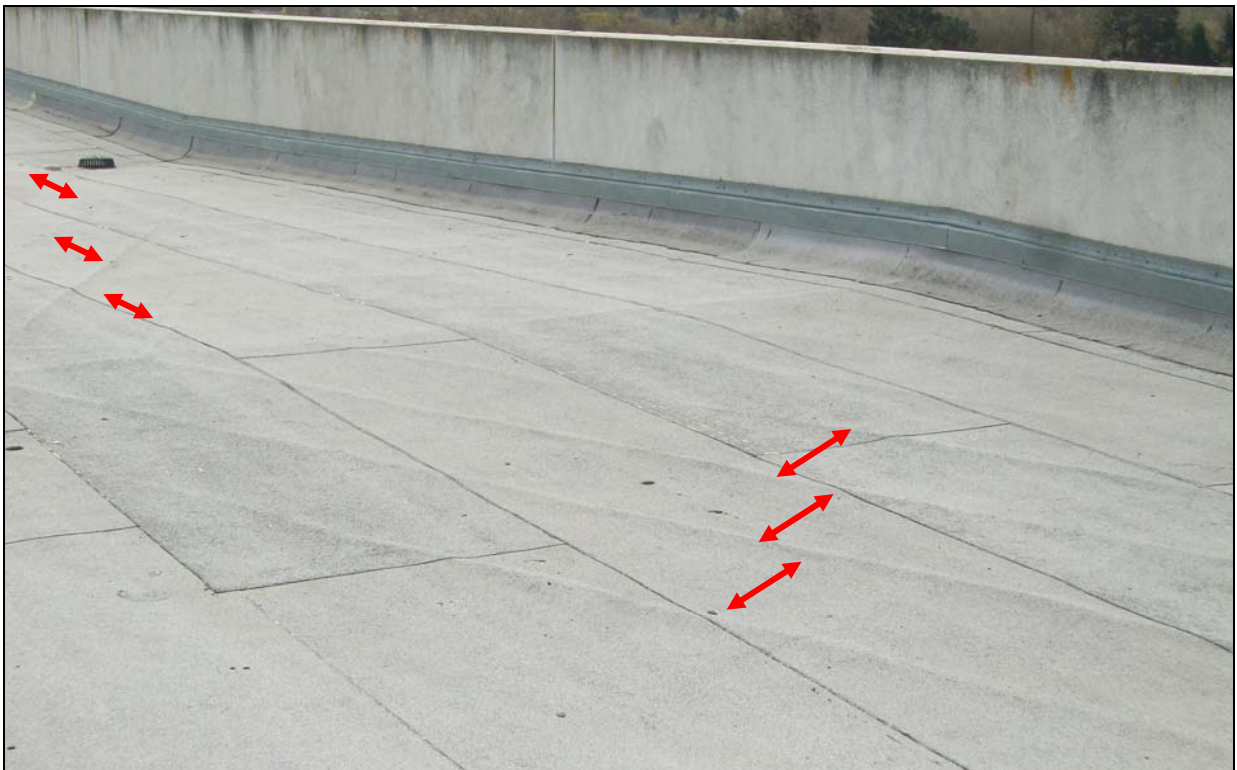
Underlying Membrane Ridging (close-up)

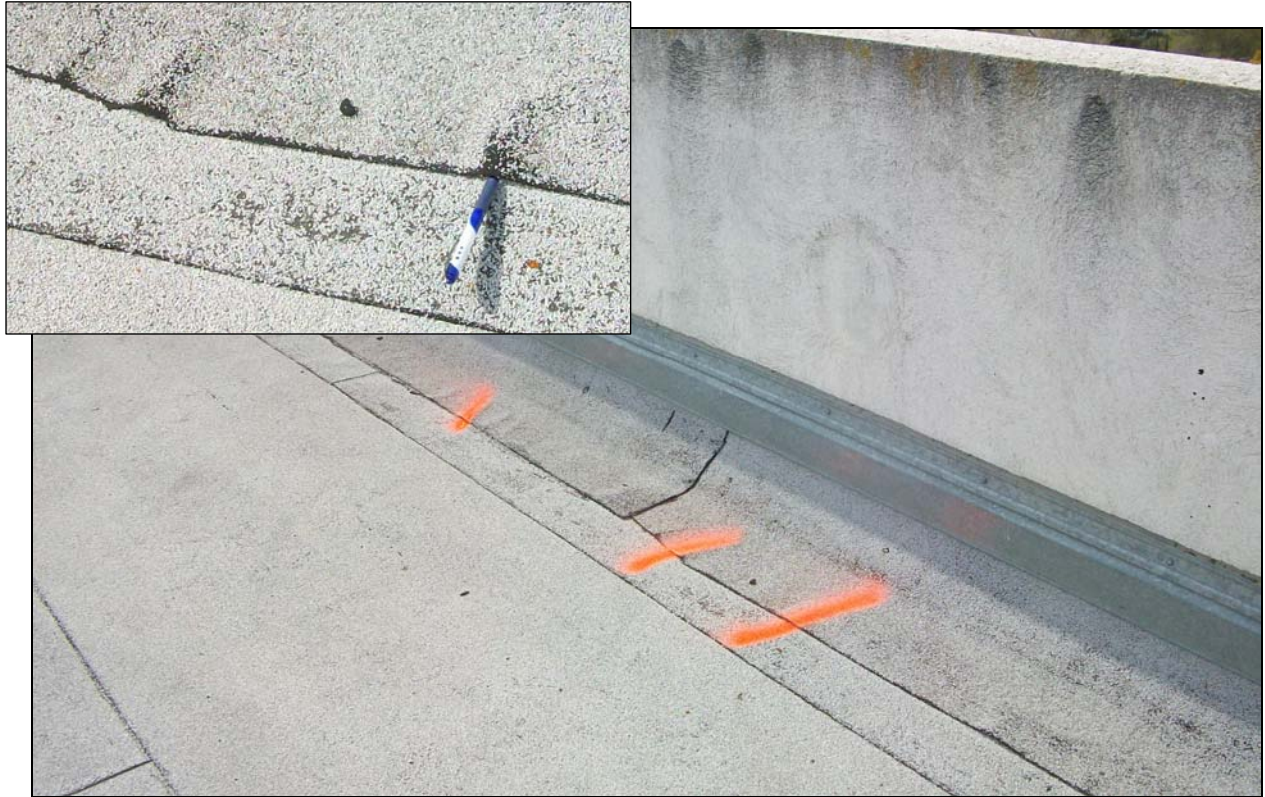
Fish-Mouth Openings – Base Flashing Repairs

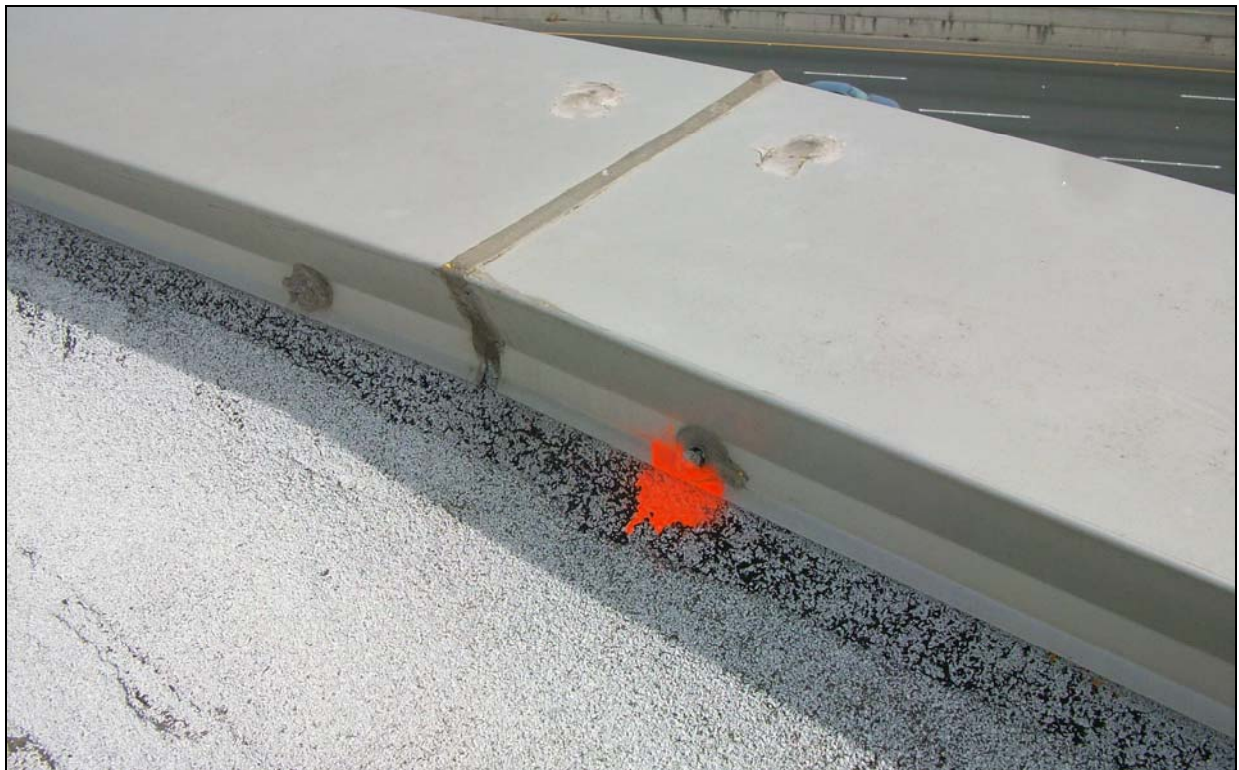
- Loose coping metal fasteners

Loose Coping Metal Fasteners

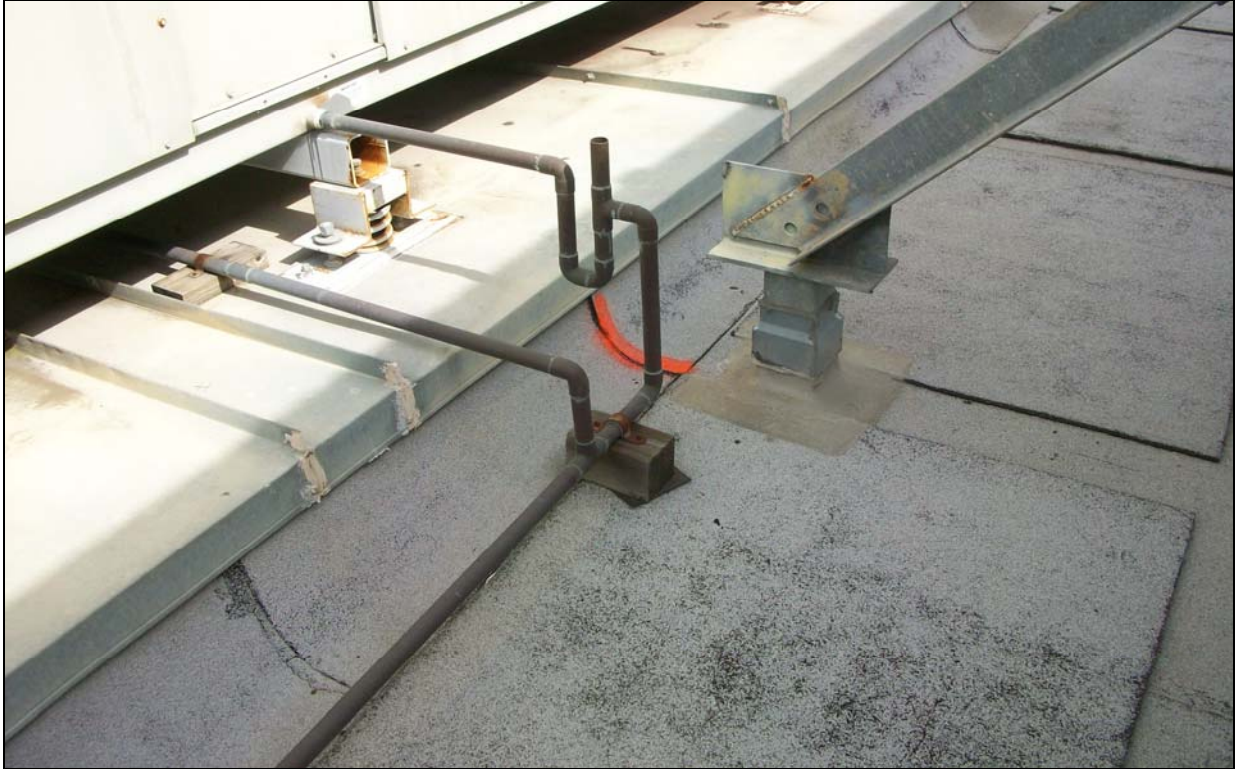
Open / Exposed Base Flashing Seams

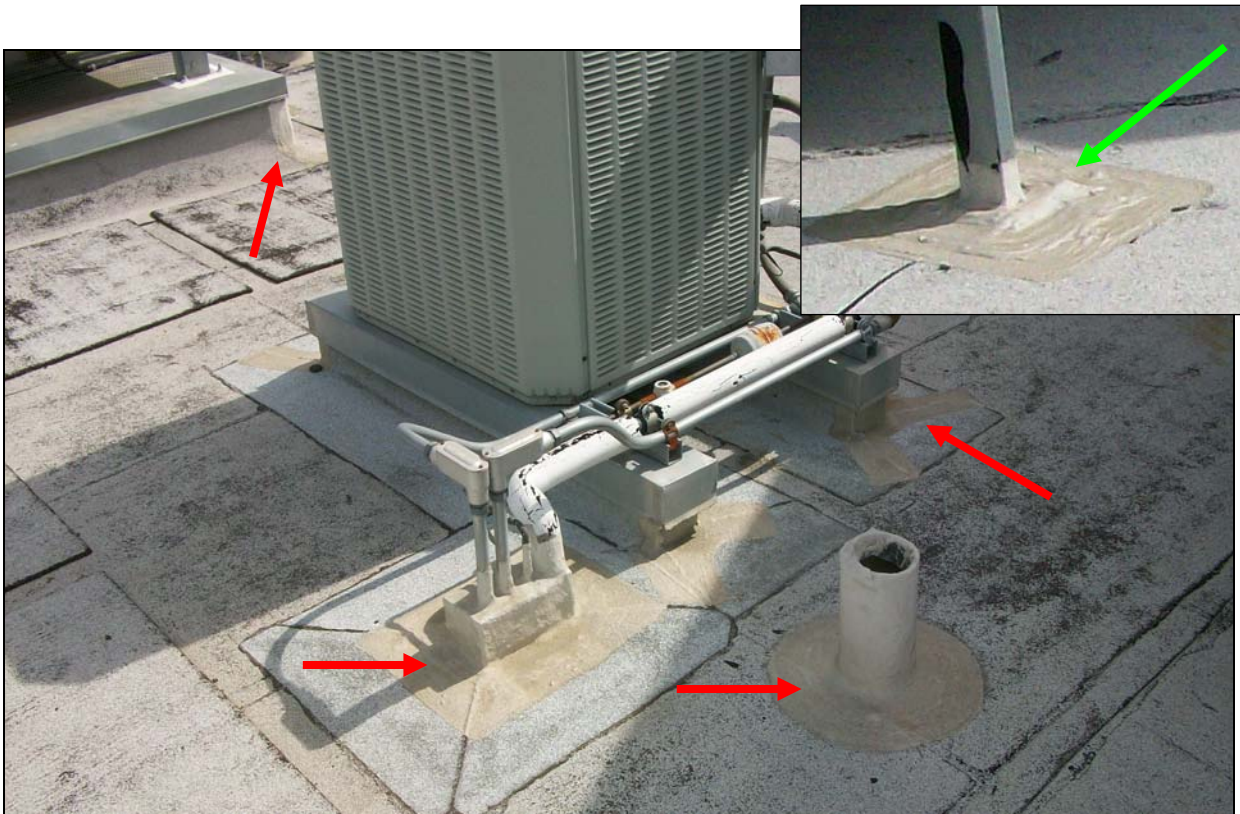
Blanket Previous Repairs
