San Mateo County Board of Supervisors Meeting

Applicant: **Mahon**

File Numbers: **PLN 2000 - 00016**

Corrected Notice of Decision

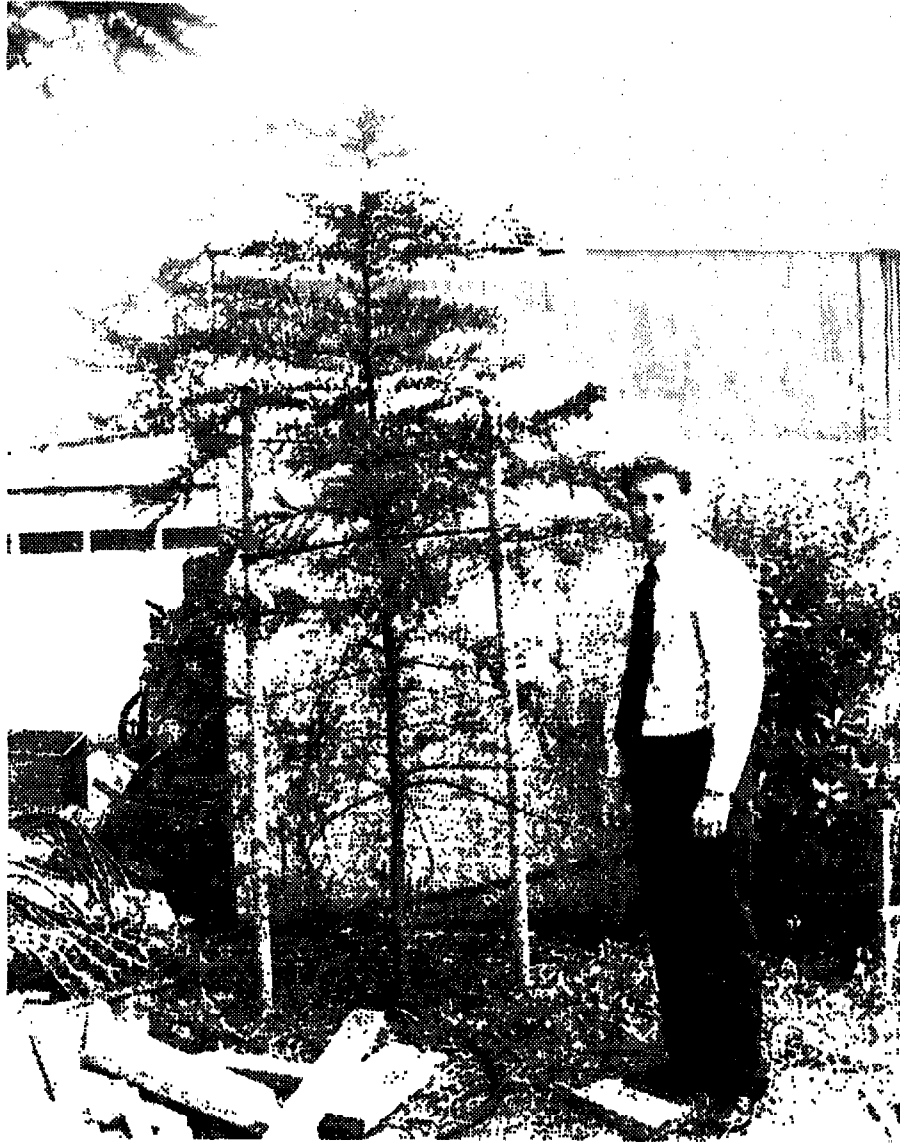
Tree #2 is practically dead, 99.9% of the live tissue has been removed (see on appendix A report dated 10-2-2000). This tree should be removed as soon as possible.

The Monterey Cypress (Tree #2) located in the middle of the grove is in the process of dying, it presents poor structure and it is showing signs of deterioration such as loose bark and the presence of bores and termites throughout the remaining branches and trunk.

Tree #2 should be removed, 99.9% of the live tissue was removed by topping cuts, the tree does not have enough foliage to sustain itself alive, it is an eminent hazard. (see on appendix A report dated 10-2-2000).

This tree should be removed using the safety practices of ANSI 133.1-1994

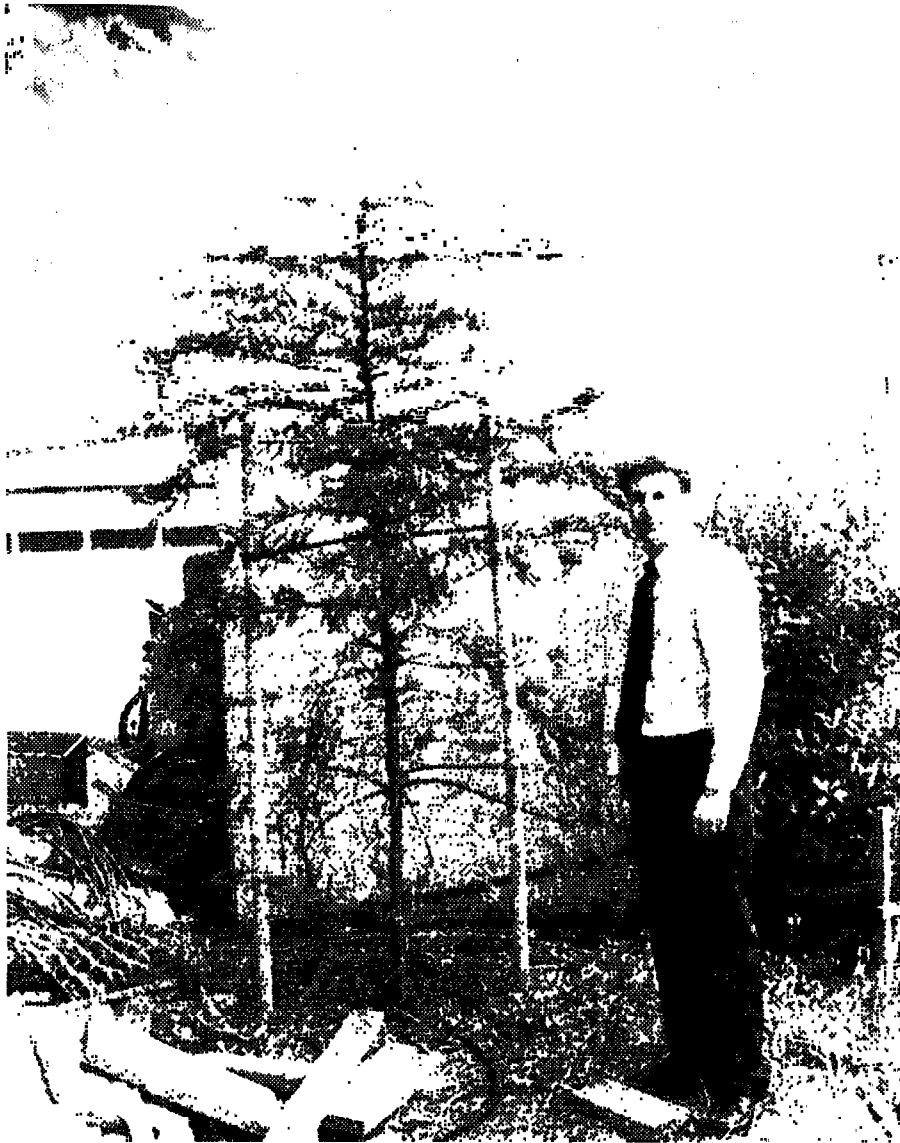
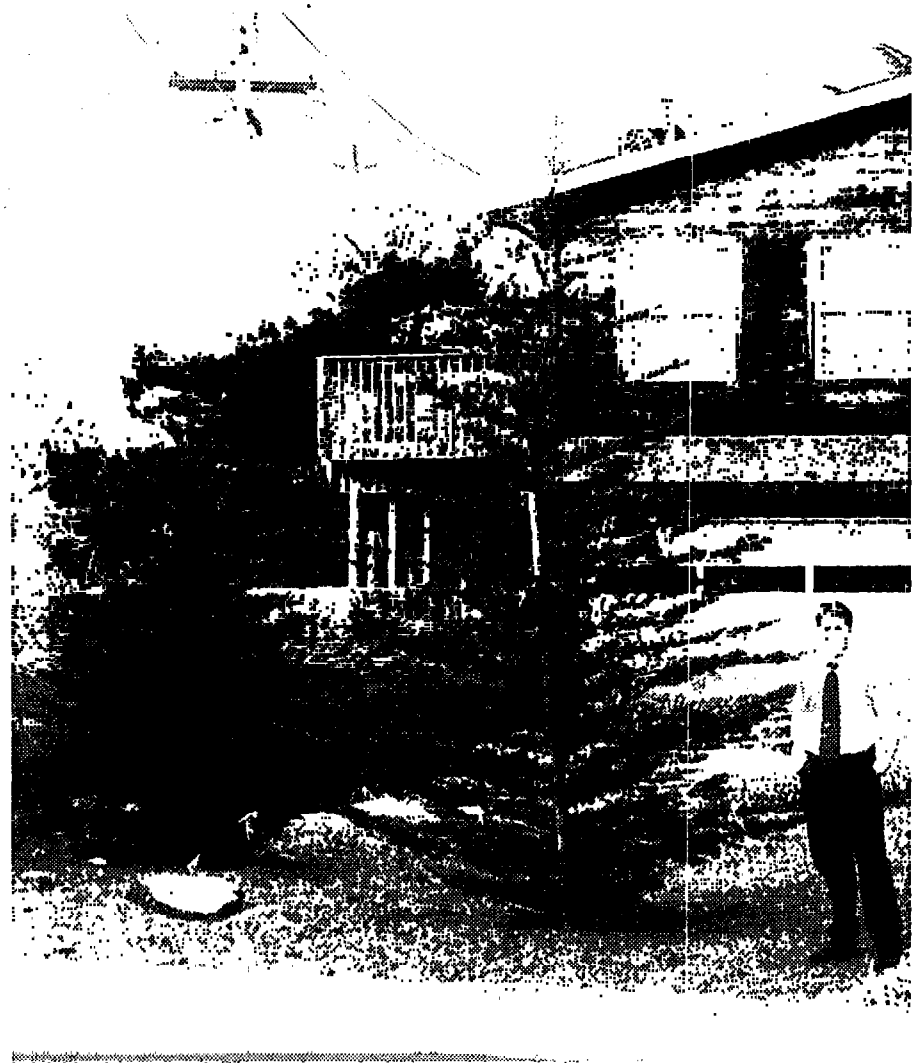
Comparison of subject trees against healthy and maintained trees of the same type located in the neighborhood.
