## GEOLOGIC SUMMARY OF CONDITIONS ALONG OCEAN BOULEVARD, MOSS BEACH

The County roads in the Seal Cove area have been affected in various ways over the years by the movement of the active coastal landslides in that area. The most recent movement has caused Ocean Boulevard, between Los Banos Avenue and Madrone Avenue, to become uneven and to tilt steeply toward the sea.

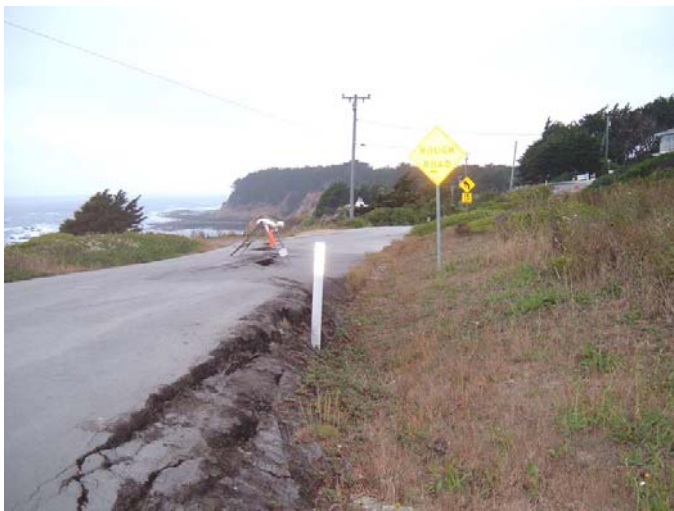
The southern end of the recent activity appears to be near the intersection of Ocean Blvd and San Lucas Avenue. This view is from that intersection, looking northward.

The graben extends into the field to the right, where there are several discontinuous parallel linear depressions in the head scarp area.

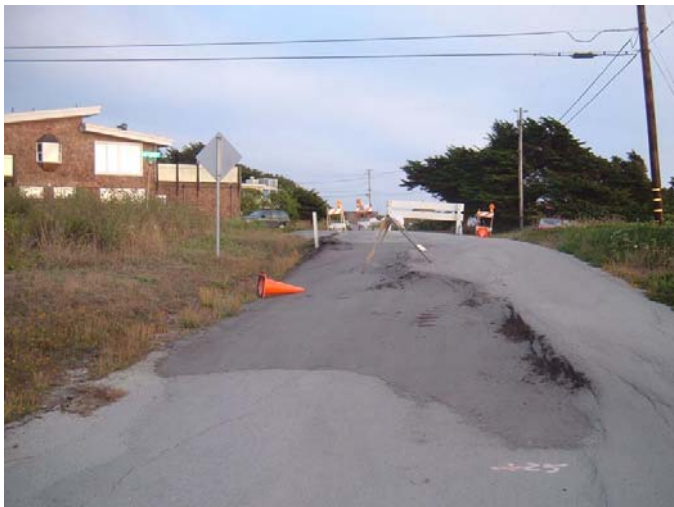
The depression shown here is the graben along the top of the rotating slide mass. The picture was taken facing southward, and the white barrier is at the intersection of Ocean and San Lucas.

The small red abandoned house is in the grove of trees on the right.

The landslide mass is apparently rotating outward as it moves downward. This has caused a graben, or closed depression, to form along the head scarp.

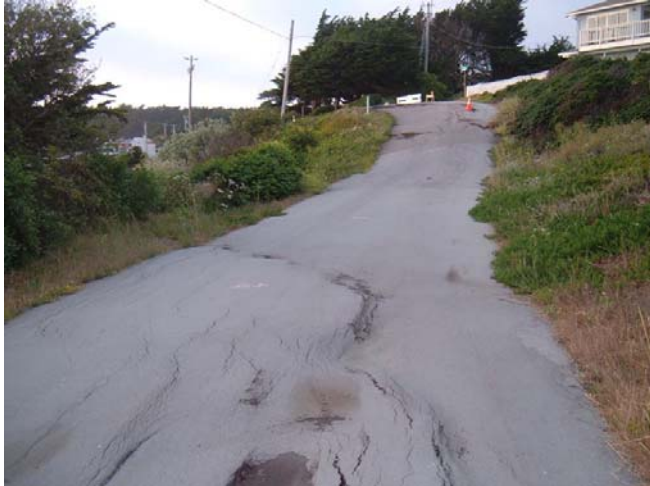
The backscarp formed along the western edge of the graben persists for some distance along Ocean Blvd, gradually leveling out and reversing itself into a normal west-facing scarp.

Downhill of the verge, the scarp is difficult to follow due to the dense vegetation. There is no well-defined landslide toe anywhere in this area.

The road steepens abruptly as it approaches its intersection with La Grande Avenue. The house in the upper right of the previous photo is at that intersection.

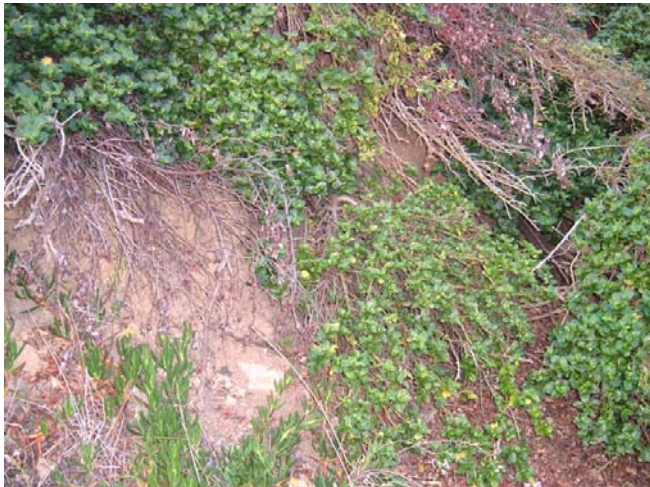
There is a fresh west-facing scarp that runs through this over-steepened portion of the road, and through the vacant lot, just below the light blue house. This scarp shows fresh soil, but its precise extent is impossible to determine due to dense vegetation.

There is water flowing through this vacant lot, close to this scarp. The source of this flow was not determined.

At the top of the hill, the intersection of Ocean and Le Grande appears to be underlain by resistant material. The boundaries of both landslides, to the north and south of it, curve away to the west (toward the sea) in this area.

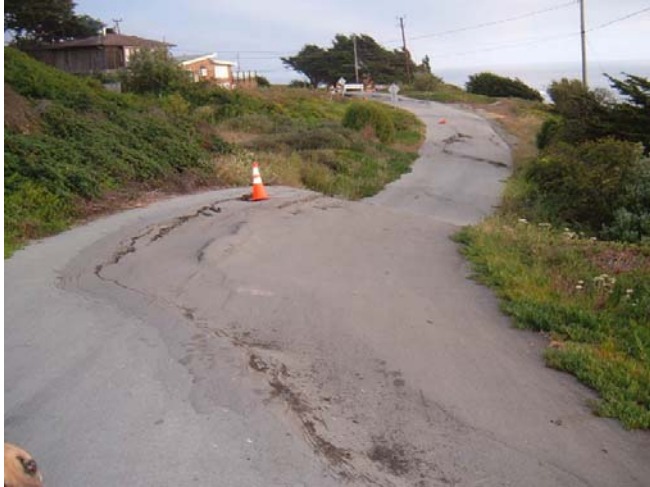
This picture shows Ocean Blvd. from La Grande looking south to San Lucas (see barrier in distance). The road is offset along the cracks by as much as 6" vertically. The angle of dip on the road is from 2 to 20 degrees west.

To the north of the Ocean/La Grande intersection, the road drops off sharply again along a steep scarp that crosses the road just downhill of the junction.

1. Abandon those sections of Ocean Boulevard and Los Banos Avenue that are currently impassable. Make the barriers permanent, and discourage any traffic through this area, including by bicycle or foot.
2. Remove paving and other structures, and regrade the slope into a natural form, with a positive grade toward the sea.
3. Revegetate the area with plants that are native to the area and that can survive with no care or additional water.
4. Require the utility companies responsible for the line of poles that are currently along the west side of Ocean Boulevard to relocate them to the east, outside the active landslide zone.
5. Provide control of drainage from the paved and developed portions of the Seal Cove area away from the two landslides. Failure to do this will probably result in continued movement in these areas, and possible headward migration of the scarps.

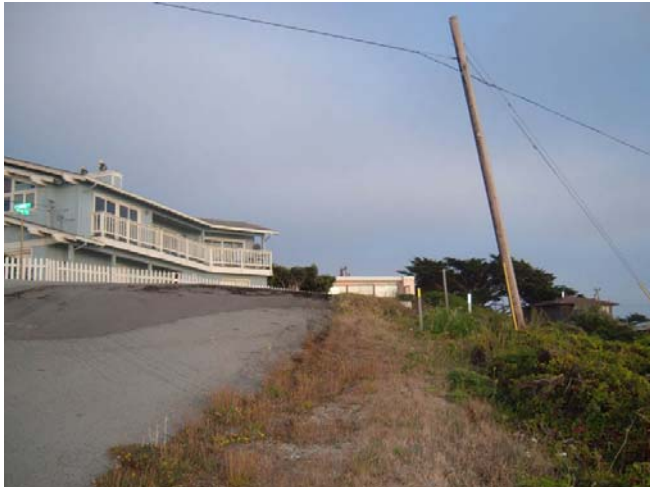
The scarp is visible as a dark wedge on the left of the photo, below the light blue house. The utility pole is one of about six that run along the west side of Ocean Blvd in this area. This is the pole that has been most affected by the movement of the slide. It is in the northern slide, near the scarp.

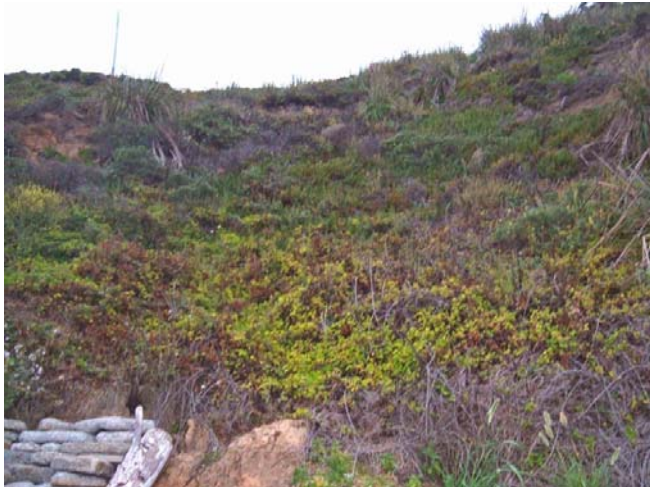
When this area is viewed from below, fresh scarps can be seen in several places, mostly directly below the road. This photo shows the swale immediately downhill of the worst of the recent movement. The leaning pole can be seen faintly in the upper left.

There is no evidence of fresh toe material anywhere in this vicinity on the beach. It appears that the active movement along Ocean Blvd. bottoms out on the natural bench that exists about half way down the slope.

Aerial photographs show that this area has moved many times in the past, mostly as small, local failures within the larger landslide mass that makes up much of the bluff area.

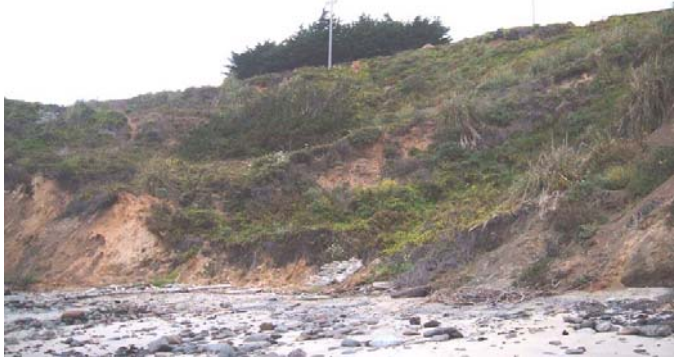
This is another photo showing the swale below the road, but looking slightly more northward than the previous one. The cement “steps” are in the middle at the base of the slope here, for reference. The benched form of the slope is evident, as is the lack of recent movement at the beach level.

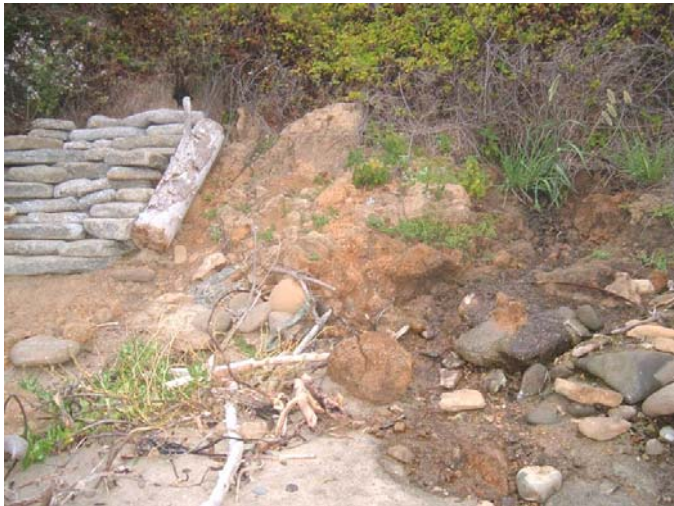
There is a stream coming out at the base of the slope below the distressed portion of Ocean Blvd. On the east side of the road above, there is evidence of uncontrolled drainage coming through the vacant lot. This water may be a contributing factor in the recent movement.

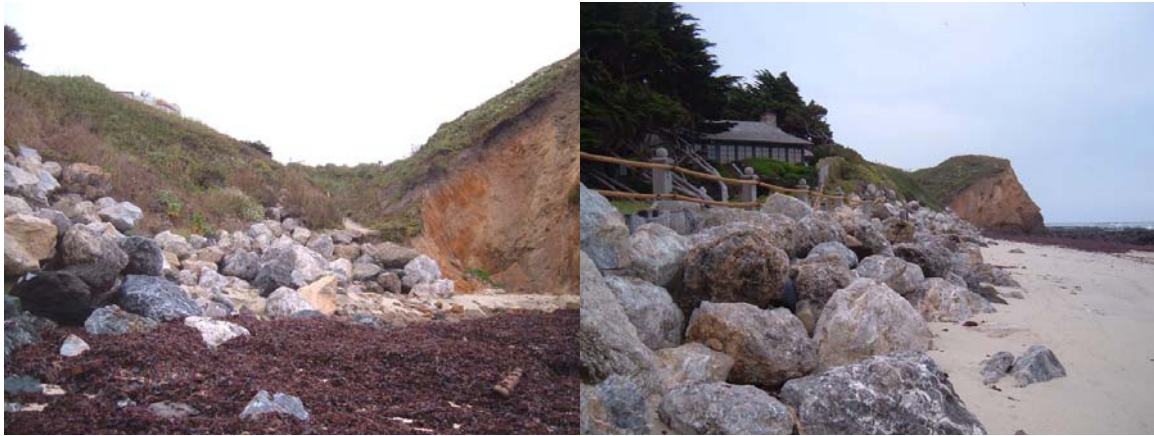
The left photo shows the small cove below the Distillery, which can be seen on the top of the bluff to the left. The picture on the right shows riprap on the beach near one of the houses that sits almost right on the beach. The exposed cliff on the right of the Distillery picture is visible in the distance on the right photo.

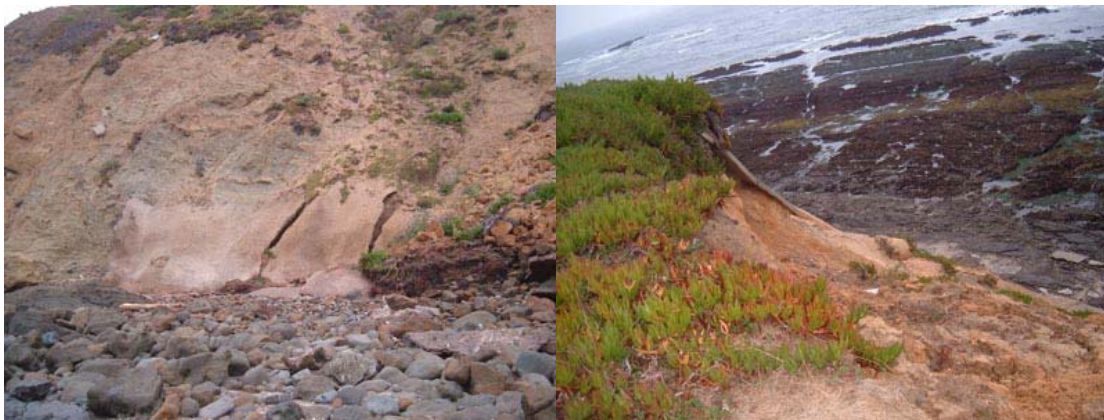
The picture on the left shows part of an old cement “blanket” that sits below the occupied house near the Distillery. It is broken, and the ocean has eroded the rock from behind it. The photo on the right shows the edge (just below the dark green bluff) of another partial blanket of cement that exists downhill of the Ocean Blvd. area that is failing.
