## APPENDIX C

EHTESHAMI PROPERTY  
21 Estrada Place,  
Redwood cCty, San Mateo County, California.

**REPORT**  
**GEOTECHNICAL INVESTIGATION**  
**INCLUDING SLOPE STABILITY ANALYSIS**  
**AND GEOLOGIC HAZARD ASSESSMENT**

**PROPOSED RESIDENCE ON PARCEL 1  
21 ESTRADA PLACE, REDWOOD CITY  
SAN MATEO COUNTY, CALIFORNIA**

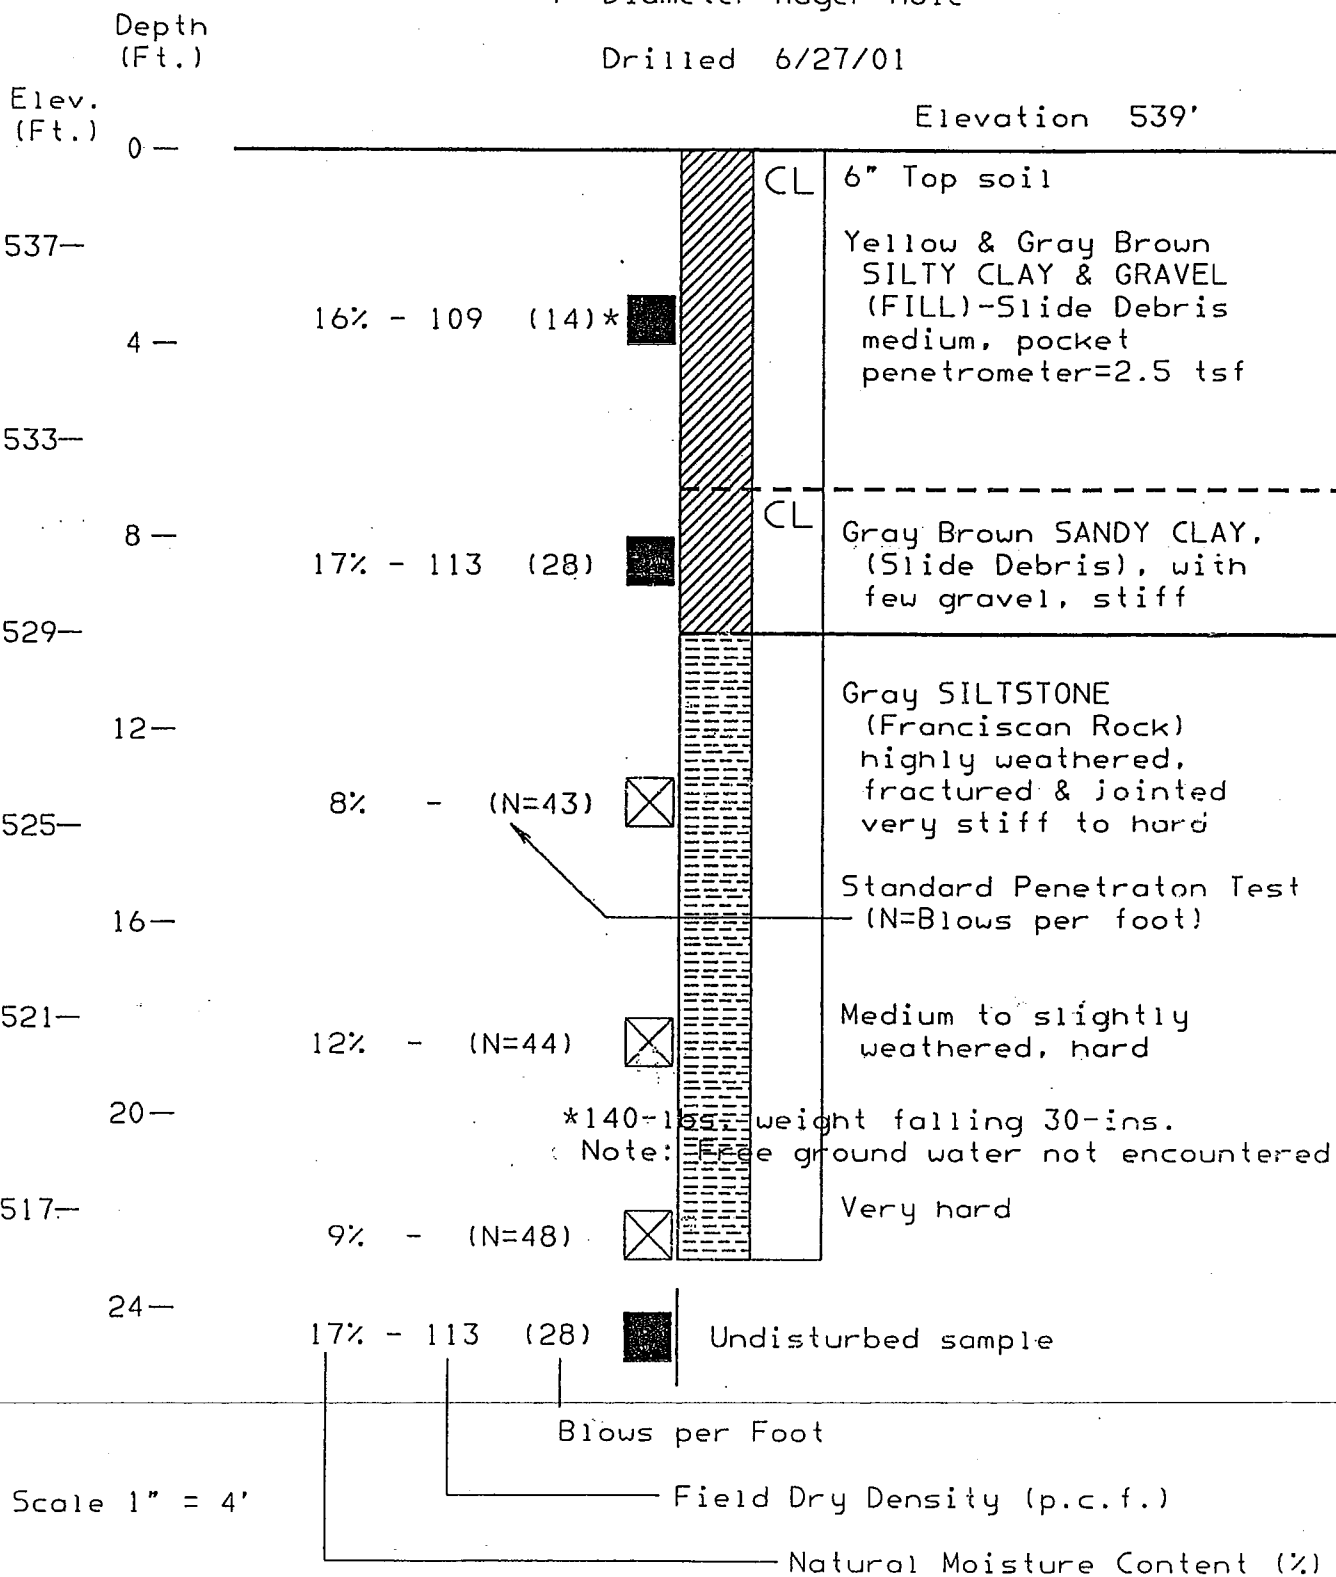
GEOTECHNICAL ENGINEERING, INC.  
 PLATE 10

Three borings (identified as Borings 11, 12 and 13) were drilled on the site on June 27, 2001. The locations are shown on **Figure 2** and the boring logs are presented on **Figures 10, 11 and 12**. The borings ranged from 14 to 23 feet in depth and each of them encountered siltstone of the Franciscan Assemblage. Depth to the siltstone ranged from 7 to 10 feet below the ground surface.

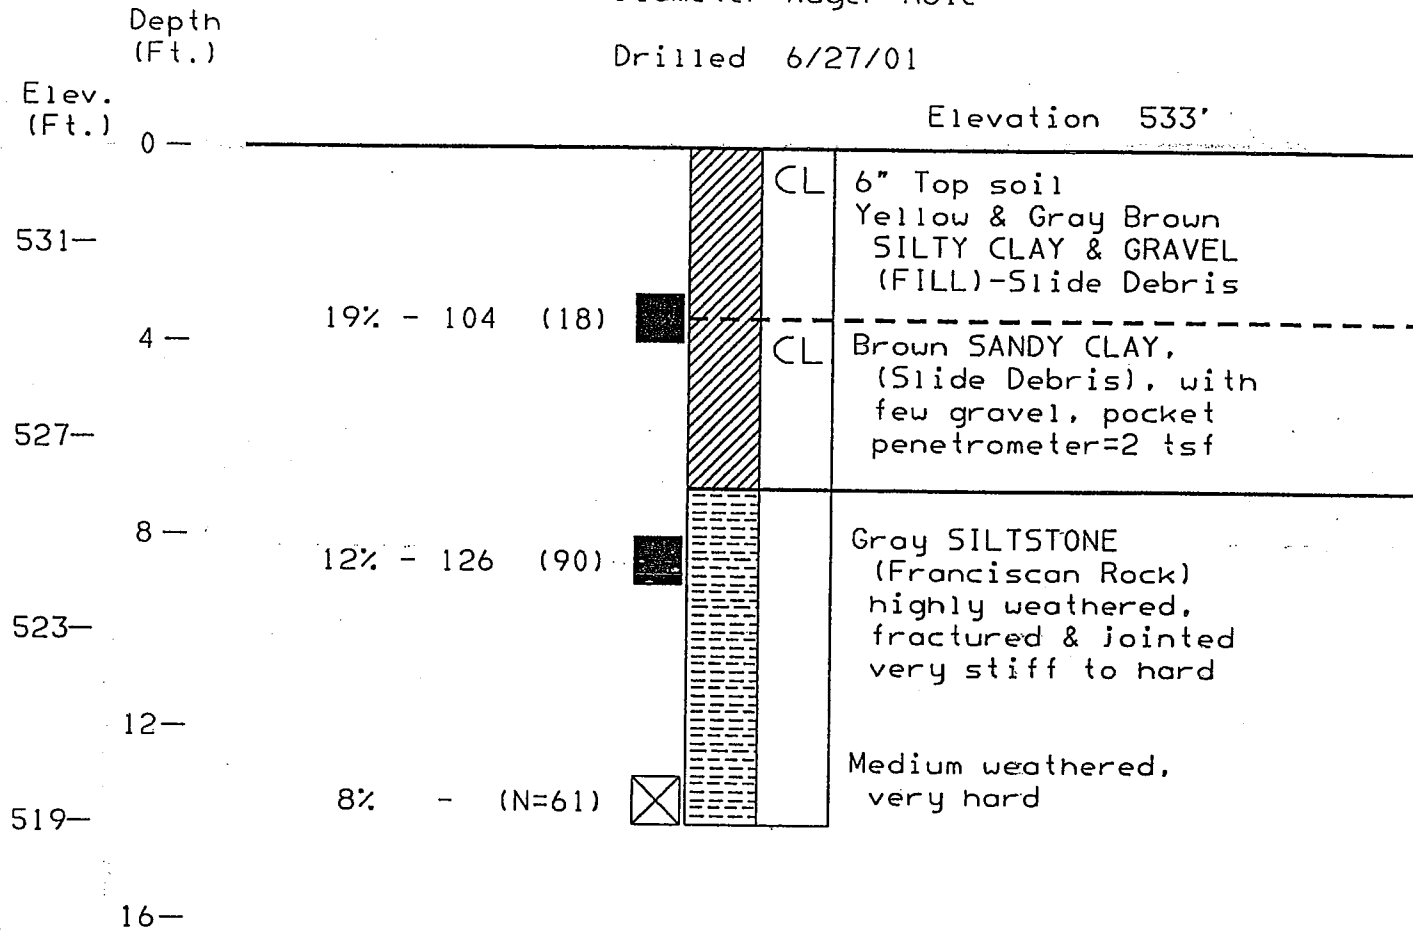
GEOTECHNICAL ENGINEERING, INC.  
PLATE 11

Note: Free ground water not encountered

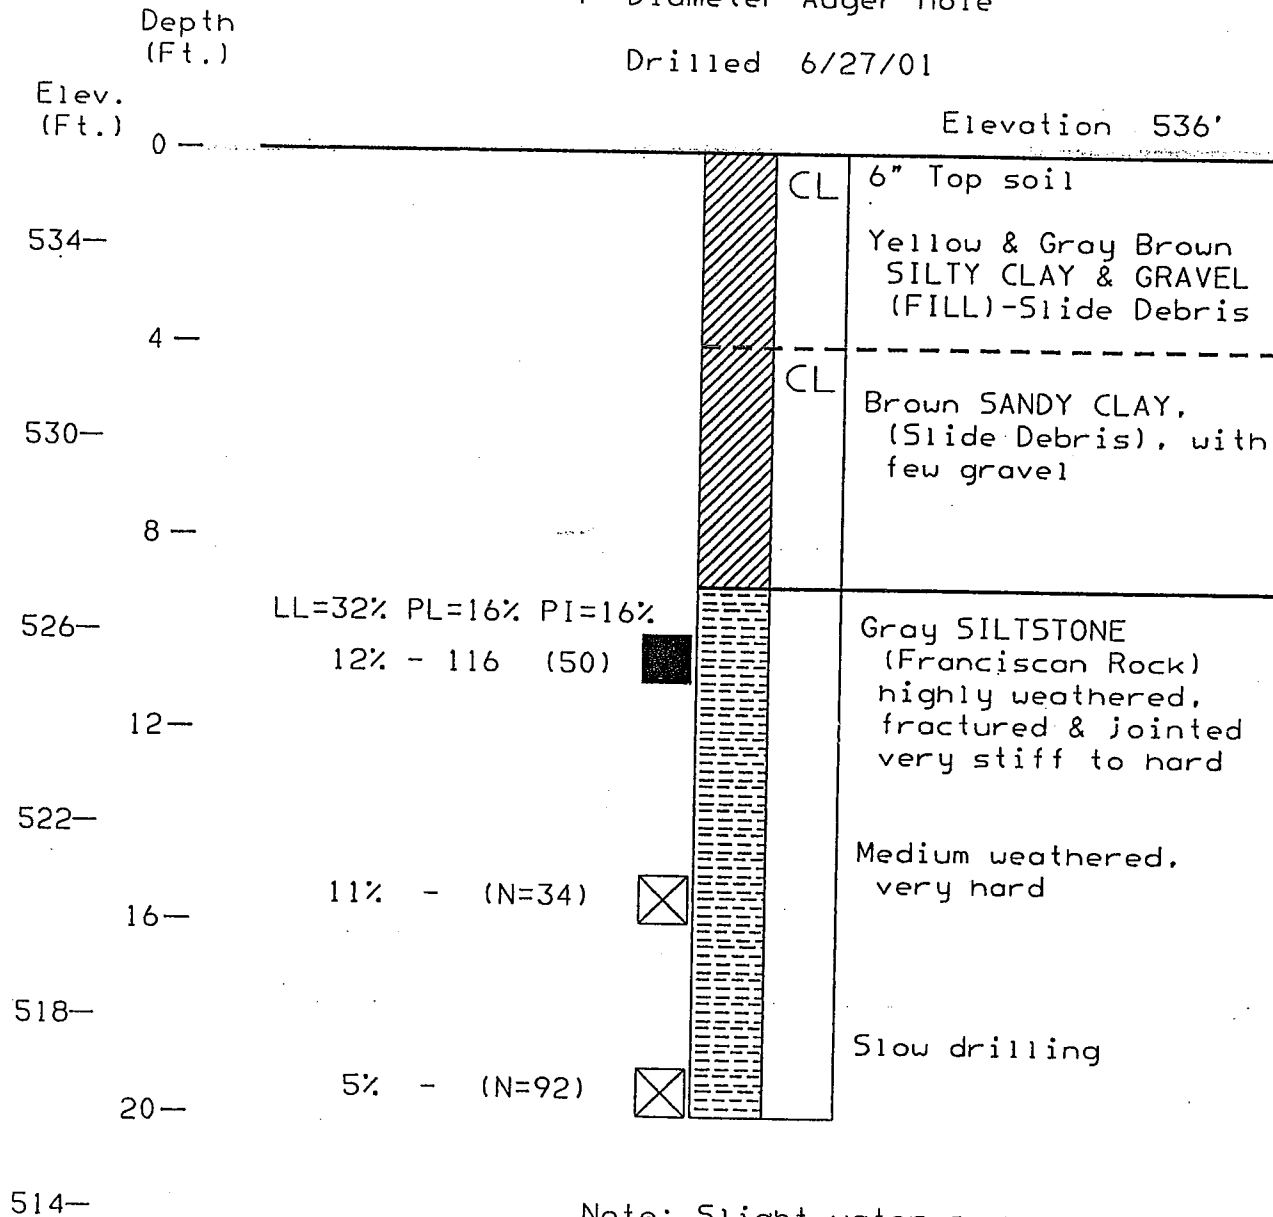
# BORING 13

Note: Slight water seepage  
@ 9' (6/27/01)  
No water at completion

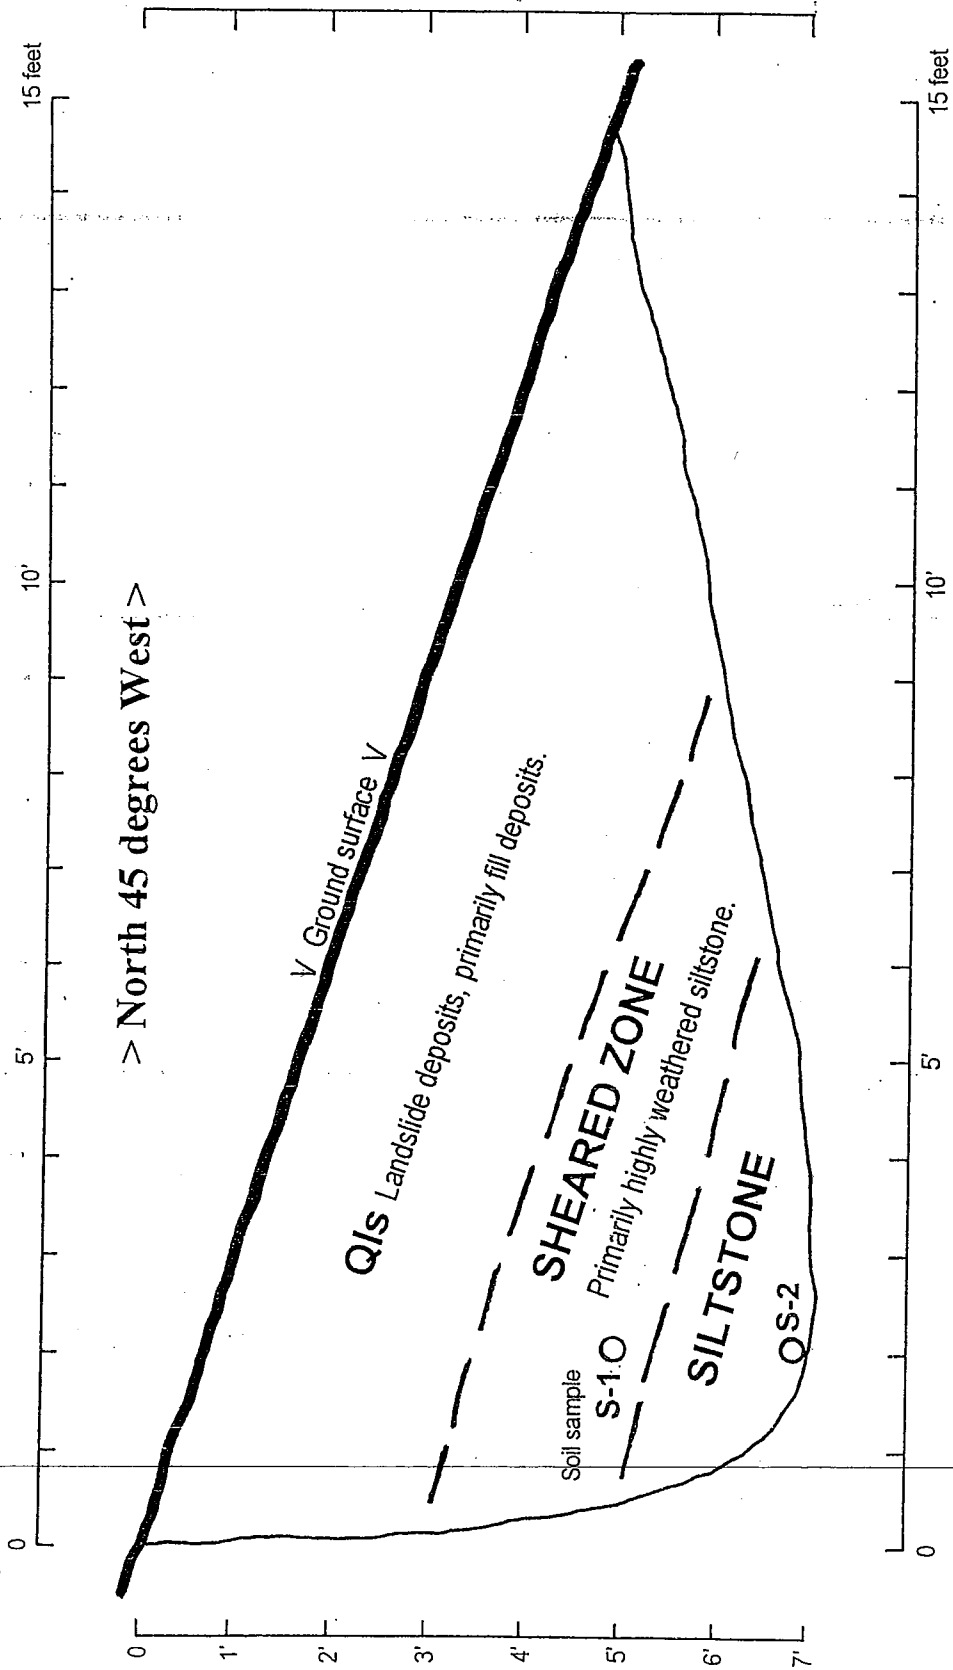
Figure 6

Test pit 14 was excavated at the base of the existing head scarp on the site (see **Figure 2** and photographs on **Figure 9**). The pit extended to a depth of approximately 7 feet. The upper 3 feet consist of disturbed material, which are referred to as land slide deposits. They consist primarily of fill deposits including angular blocks of various Franciscan Assemblage rocks in a matrix sandy to silty clay that have failed since the grading was carried for Parcel 2. The slide deposits overly approximately 2 feet of clay and silt that appear to be highly weathered siltstone. The weathered material is characterized by numerous shears that dip sub-parallel to the ground surface and is identified as a sheared zone on **Figure 6**. The base of this unit appears to be the

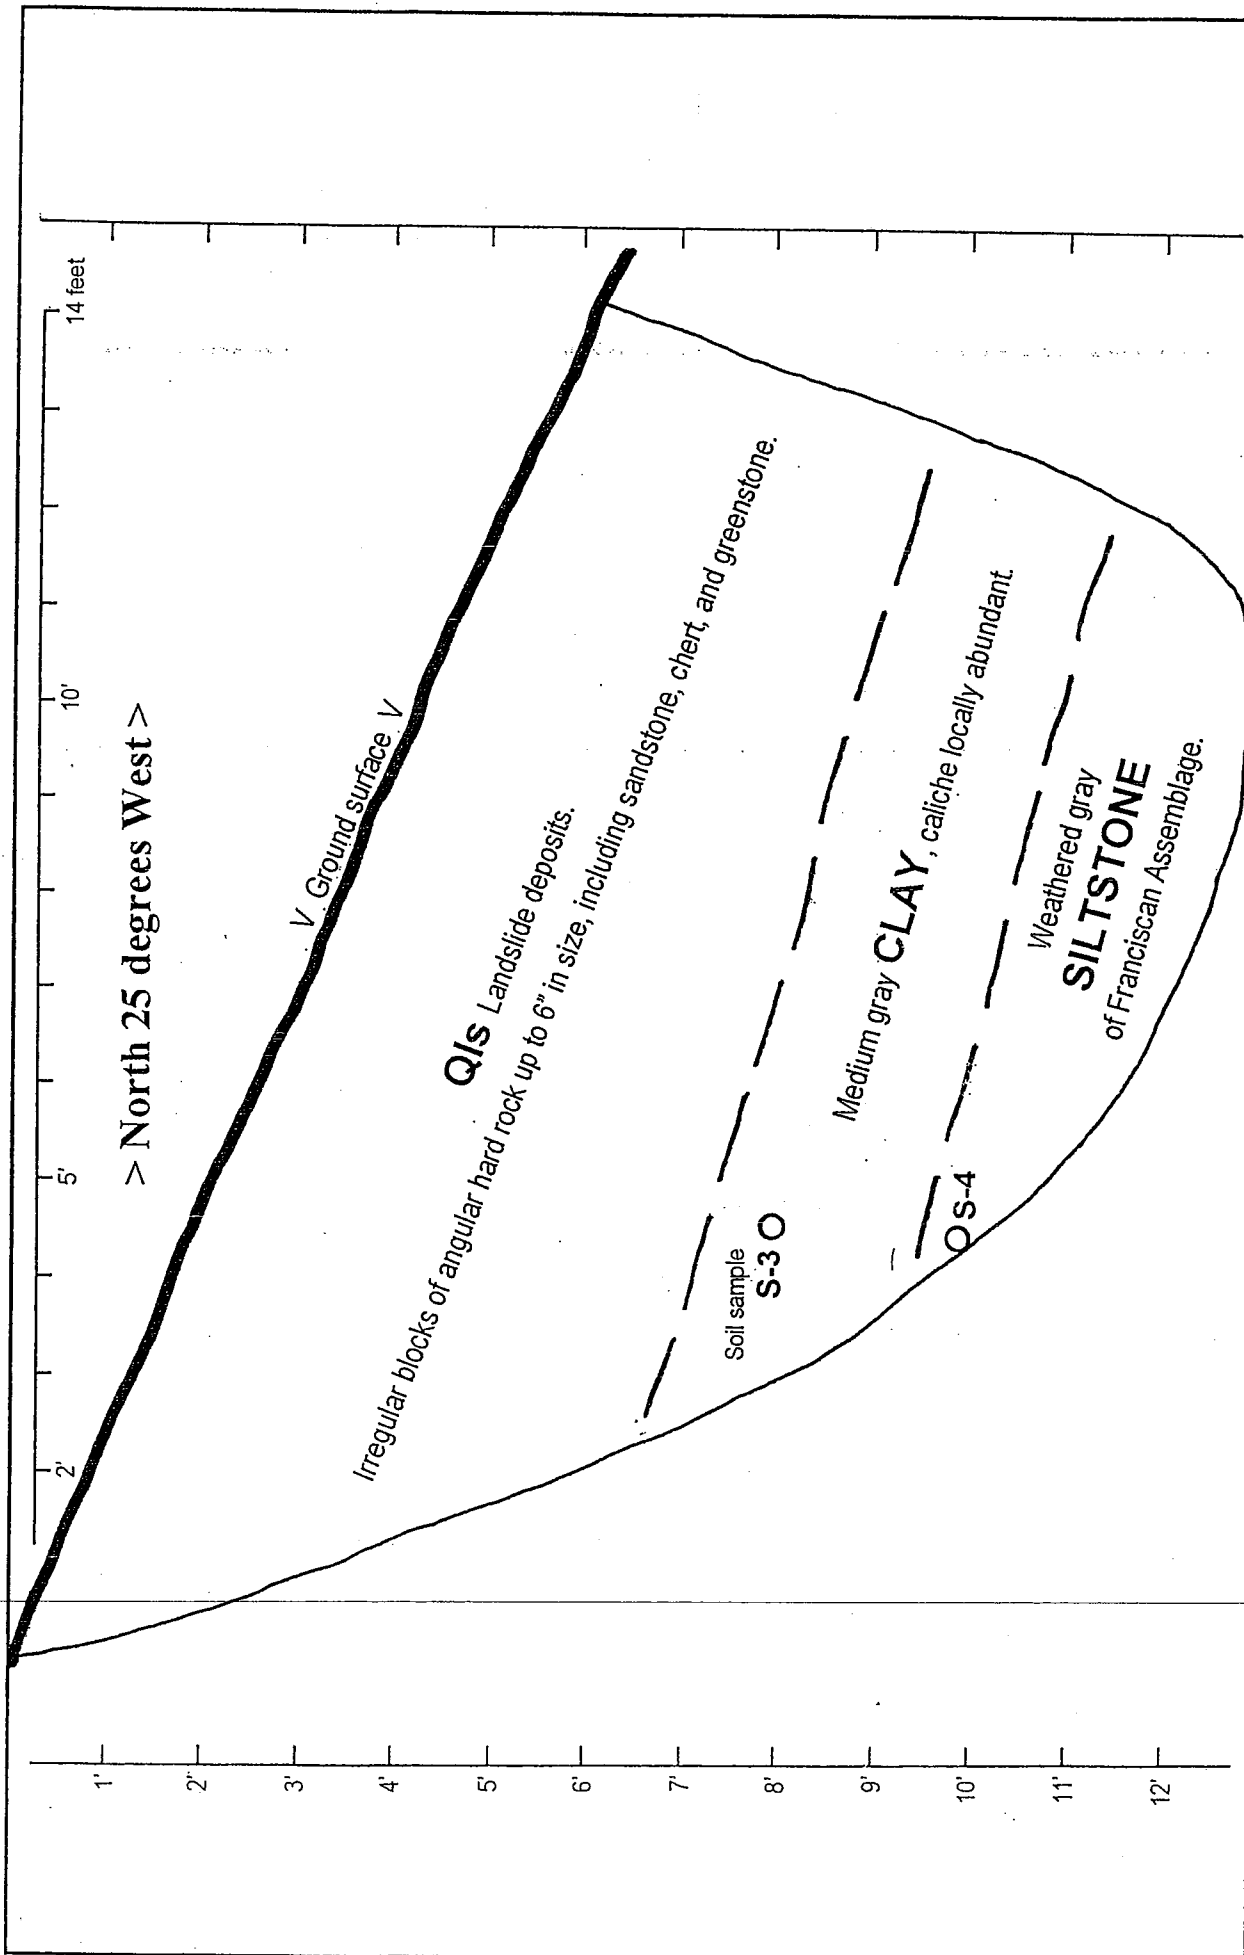
Figure 7

Two backhoe test pits were excavated on the site on June 12, 2001. The backhoe pits are identified as Test Pit 14 and Test Pit 15. The test pit locations are shown on **Figure 2** and the logs are presented on **Figures 6 and 7**. The locations of soil samples collected from the test pits are shown on the logs.

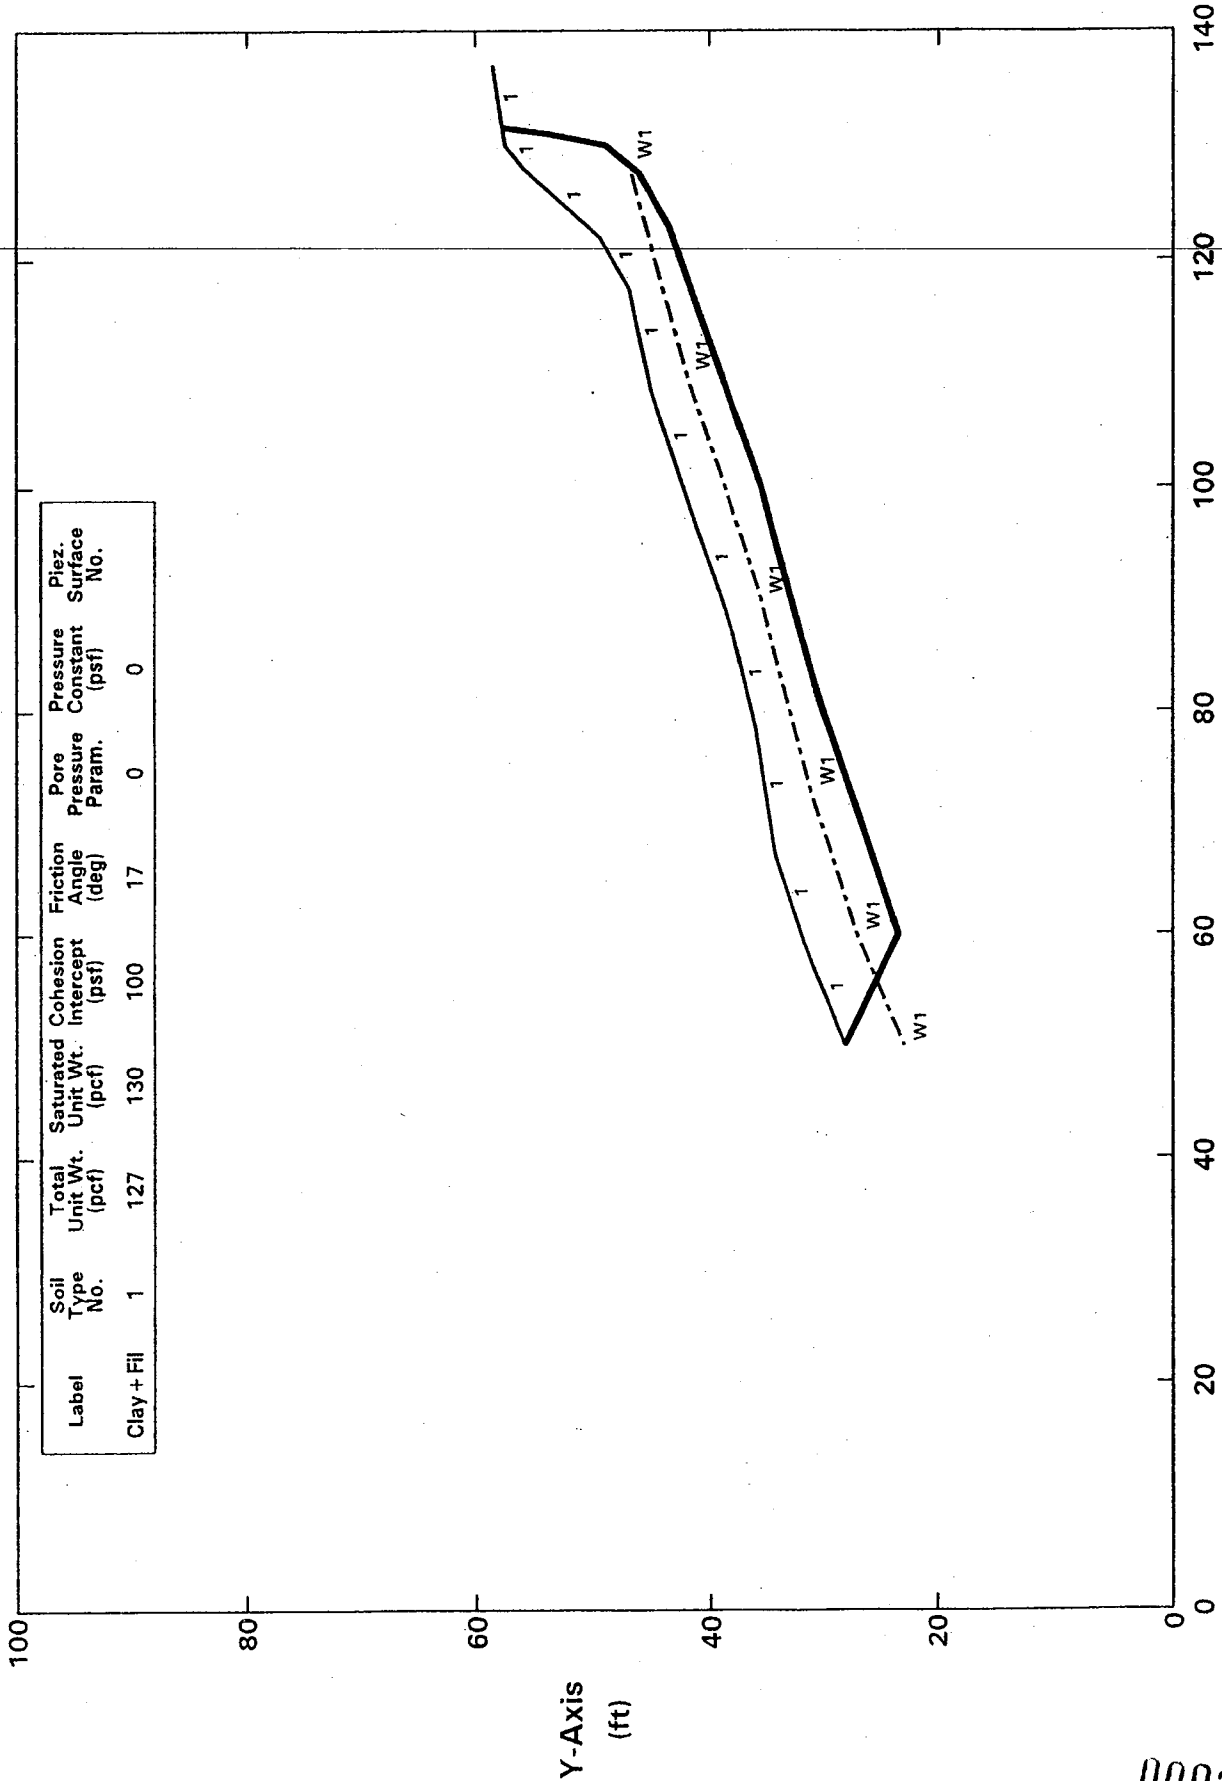
# Redwood City slope with retain wall Estrada Pl - Palomar Park - no EQ

PCSTABL5M FS = 1.48 X-Axis (ft)
