Orchard Commercial  
**Project 7700**  
2013 Annual Roof Survey

Re: 2013 Annual Roof Survey Report for **Project 7700**

# Roof Inspection Report **Project 7700**

**Project 7700** consist of two four story buildings located in San Carlos, CA 94070 at:

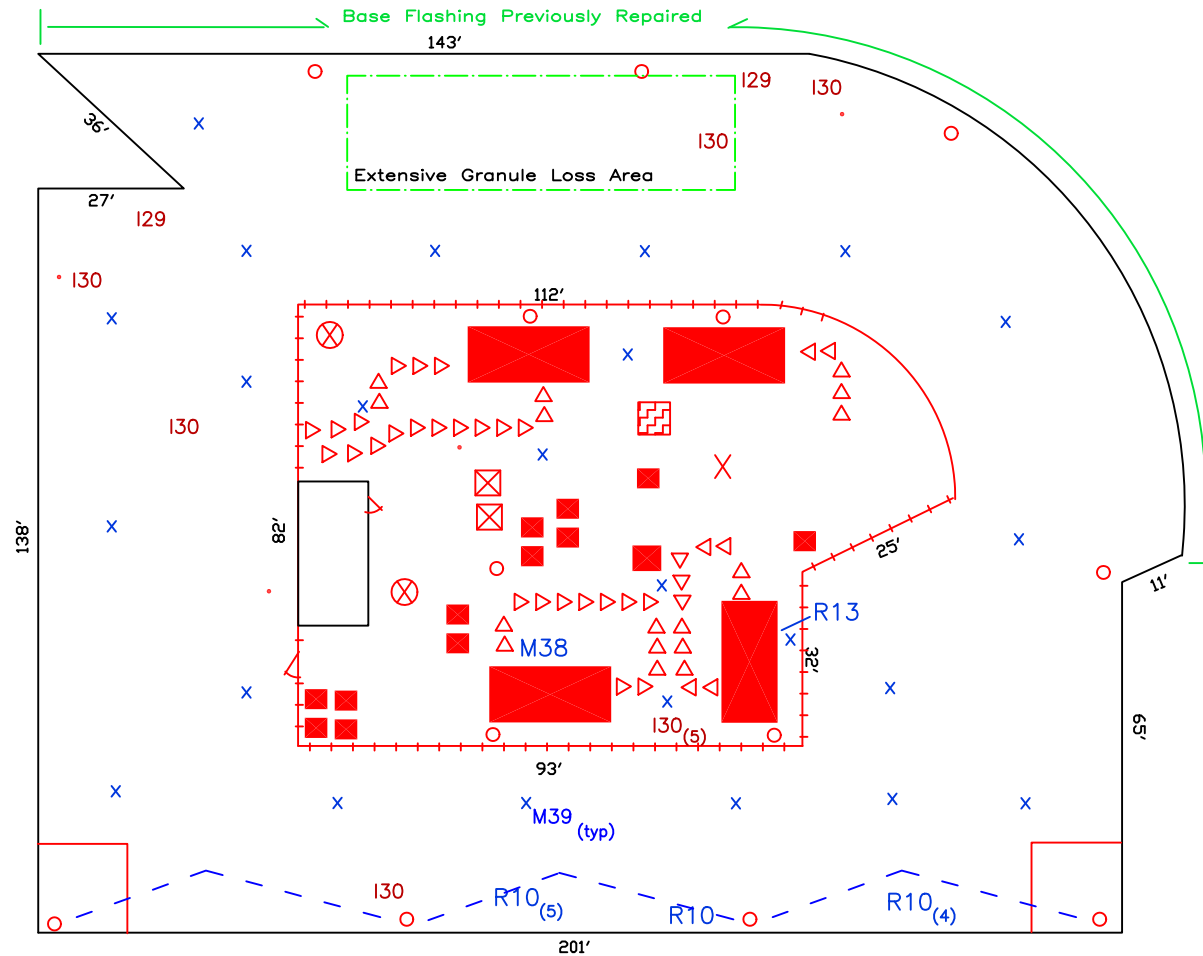
- Breather vents have been sealed by previous roof repairs

- Protection pads at Ventilation Duct Supports have been sealed with acrylic
- One breather vent (under Ventilation Duct) missing cover

x = Breather Vents (typically decommissioned)

- Budget for partial acrylic coating at extensive cap-sheet granule loss (Building Two)
  - Not included in the attached 2014 budget
- Seal base flashing seams and fish-mouth openings
- Remove breather vents during next roofing project
- Install new Cap (or seal) breather vent under ventilation duct
- Monitor field ridging, repair as required or during next roofing project
- Monitor membrane scoring (initiate care policy for service personnel)
- Monitor granule loss, repair as required
- Monitor west facing base flashings for granule loss and moisture depletion
